Adopt a Road

Bradford Conservation Commission

Summer 2022 Report

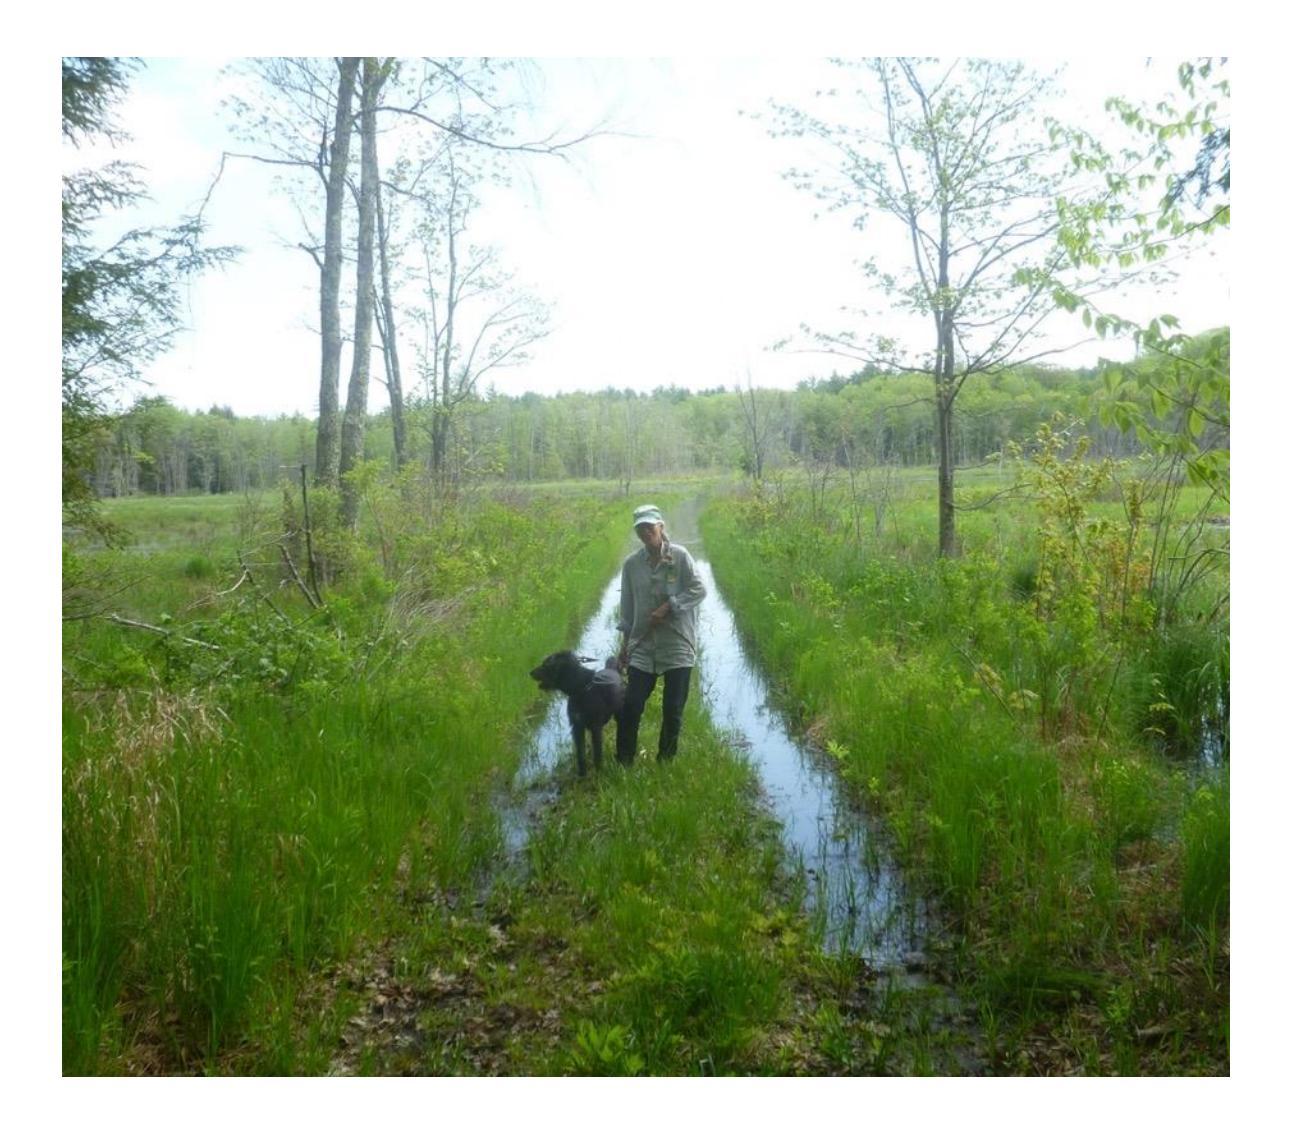
| Miles | Conditions |
|---|--|
| 1.0 | Road continues to be in Fair to Good condition, but ends in water at approximately 1 mile (see pic). |

Obstructions: Standing water in some areas of the road as previously noted.

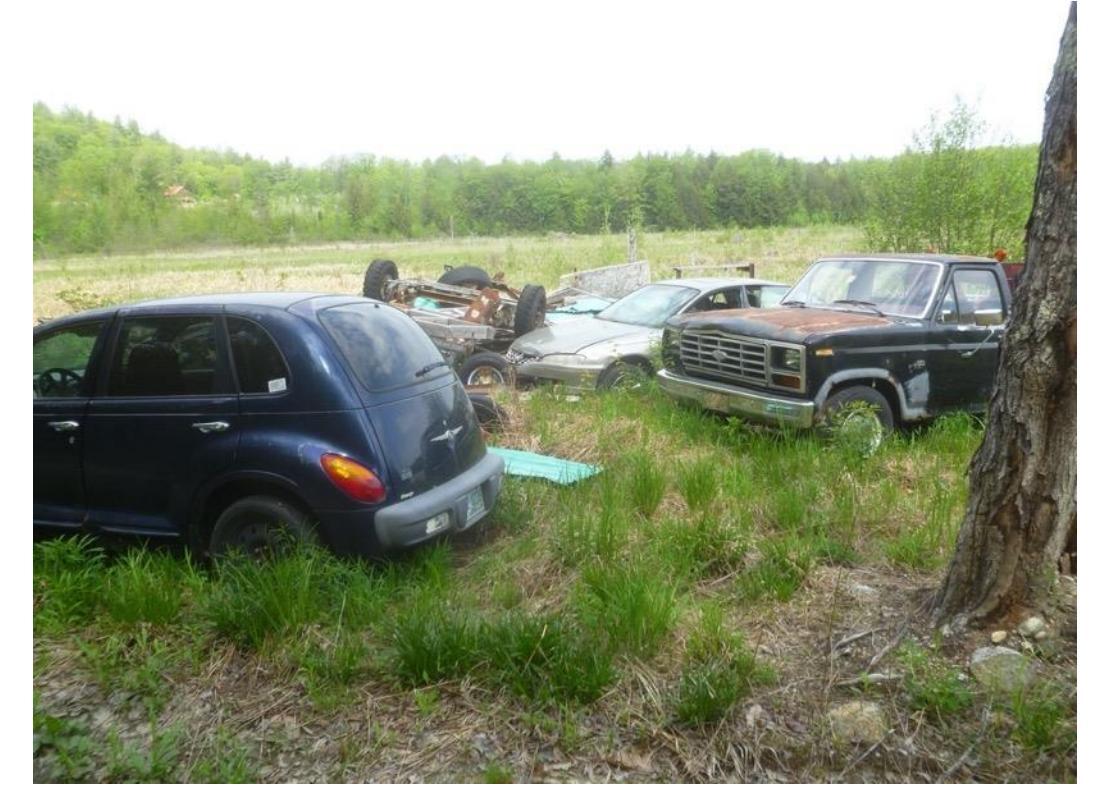
Trash/Dumping: The junk and trash piles looked similar to the report of Fall 2019.

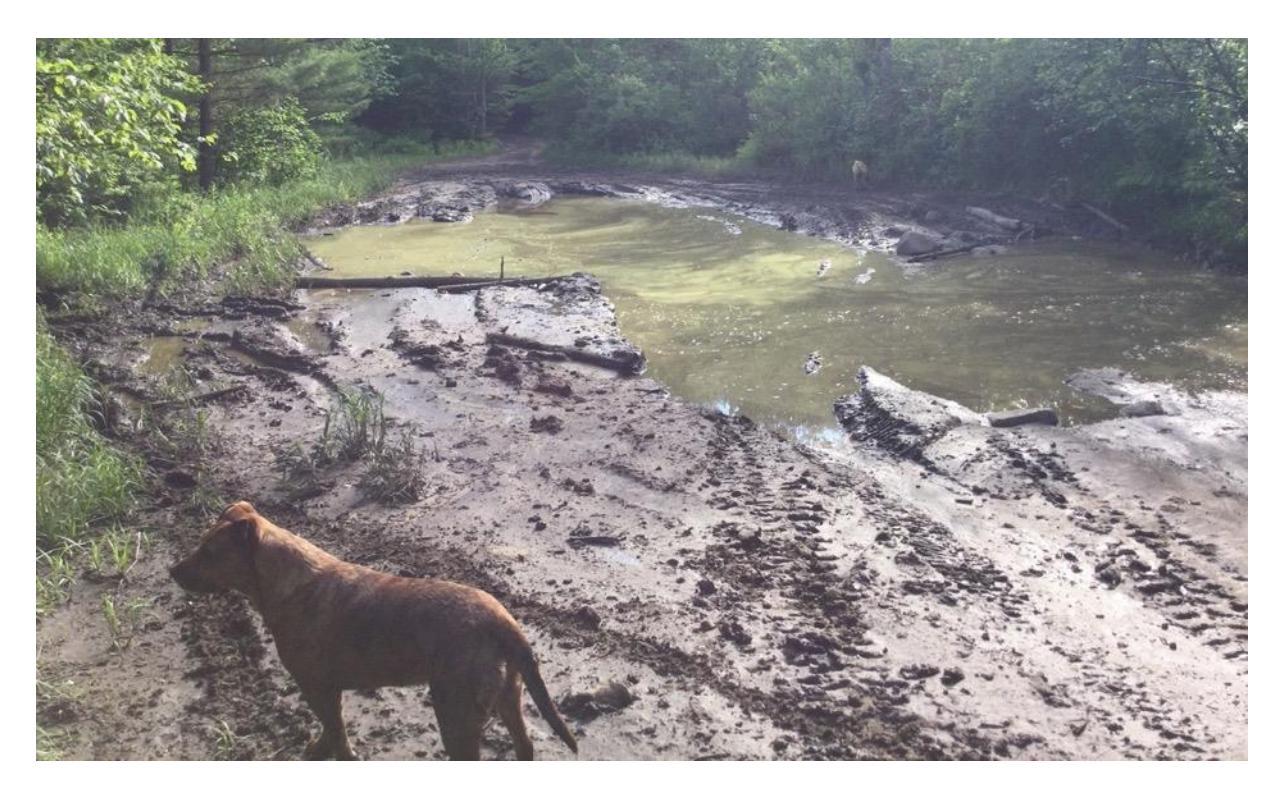
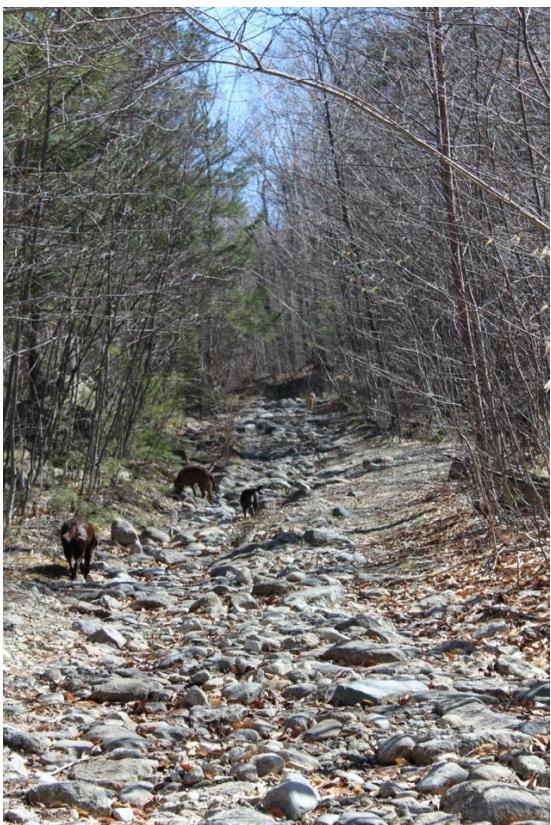
Obstructions: One low lying area has roughly 6 inches to 2 feet of muddy water, perhaps 50ft by 30ft (see picture). Mud hole hasn't seemed to increase in size, but another bypass has been cut through the low-lying forest to allow ATVs to pass. The cut section is too small for Jeep's.

Trash/Dumping: Some trash. A small residual campfire with beer cans is located by the flooded section.

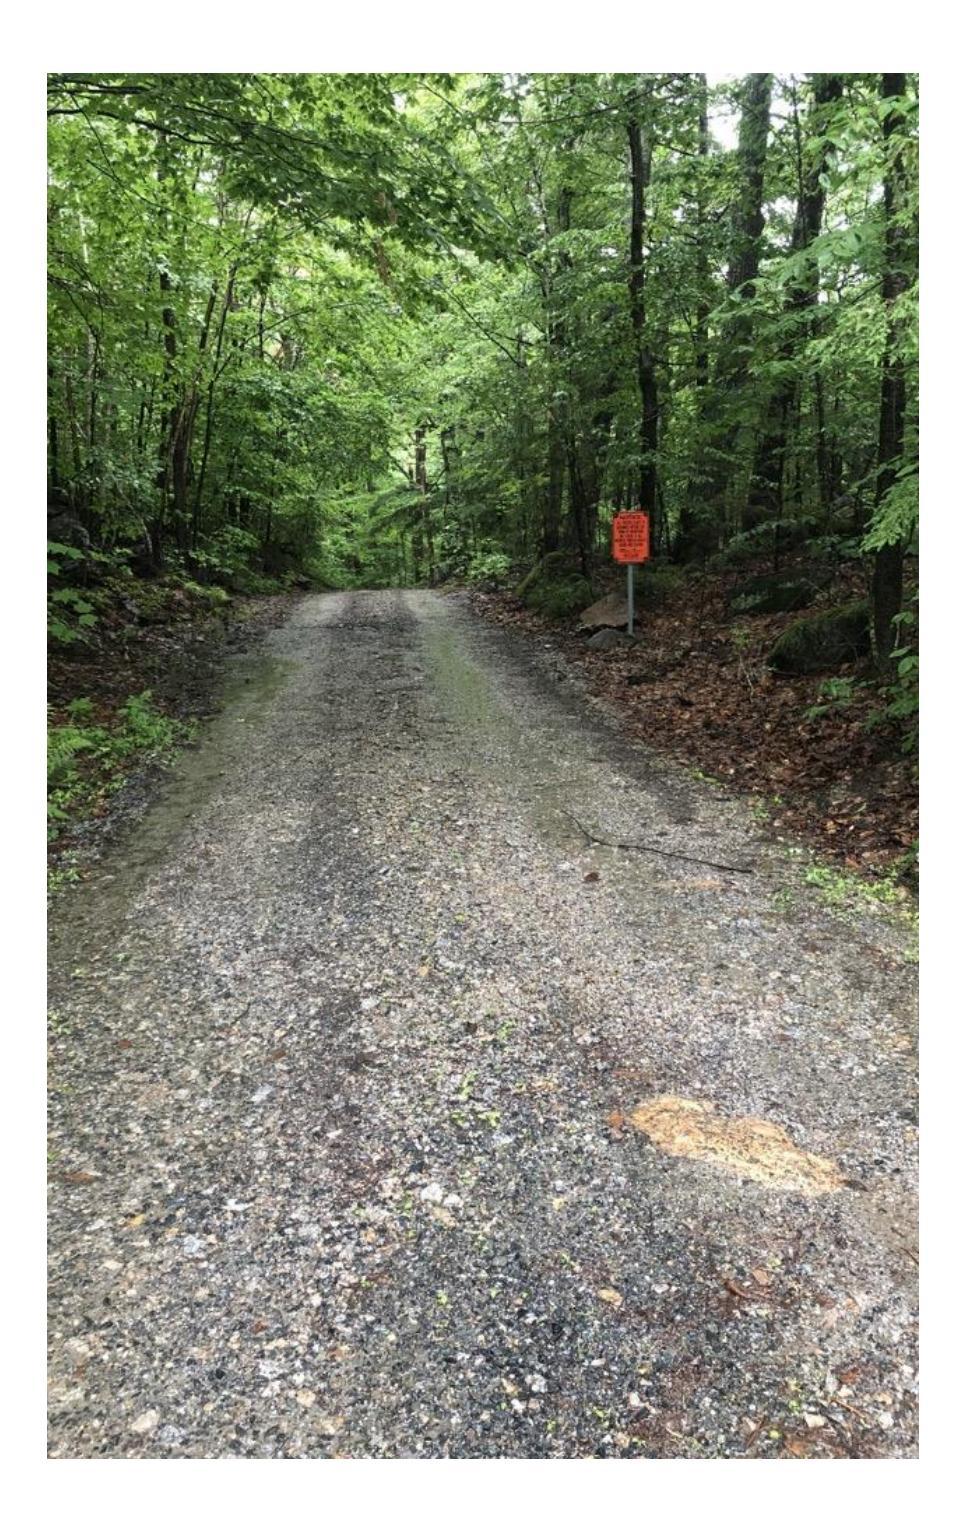
Erosion: The State of NH logged out past the Bradford line. They upgraded the short section that was past the last habitation to get their log work done. Making Bradford's section and slightly beyond very drivable. There are, however, several relatively deep water bars that have been installed. May 2022 review finds that conditions are identical to the 2021 monitoring except slight erosion on the state upgraded section. Nothing serious yet, but the early stages for sure if unchecked.

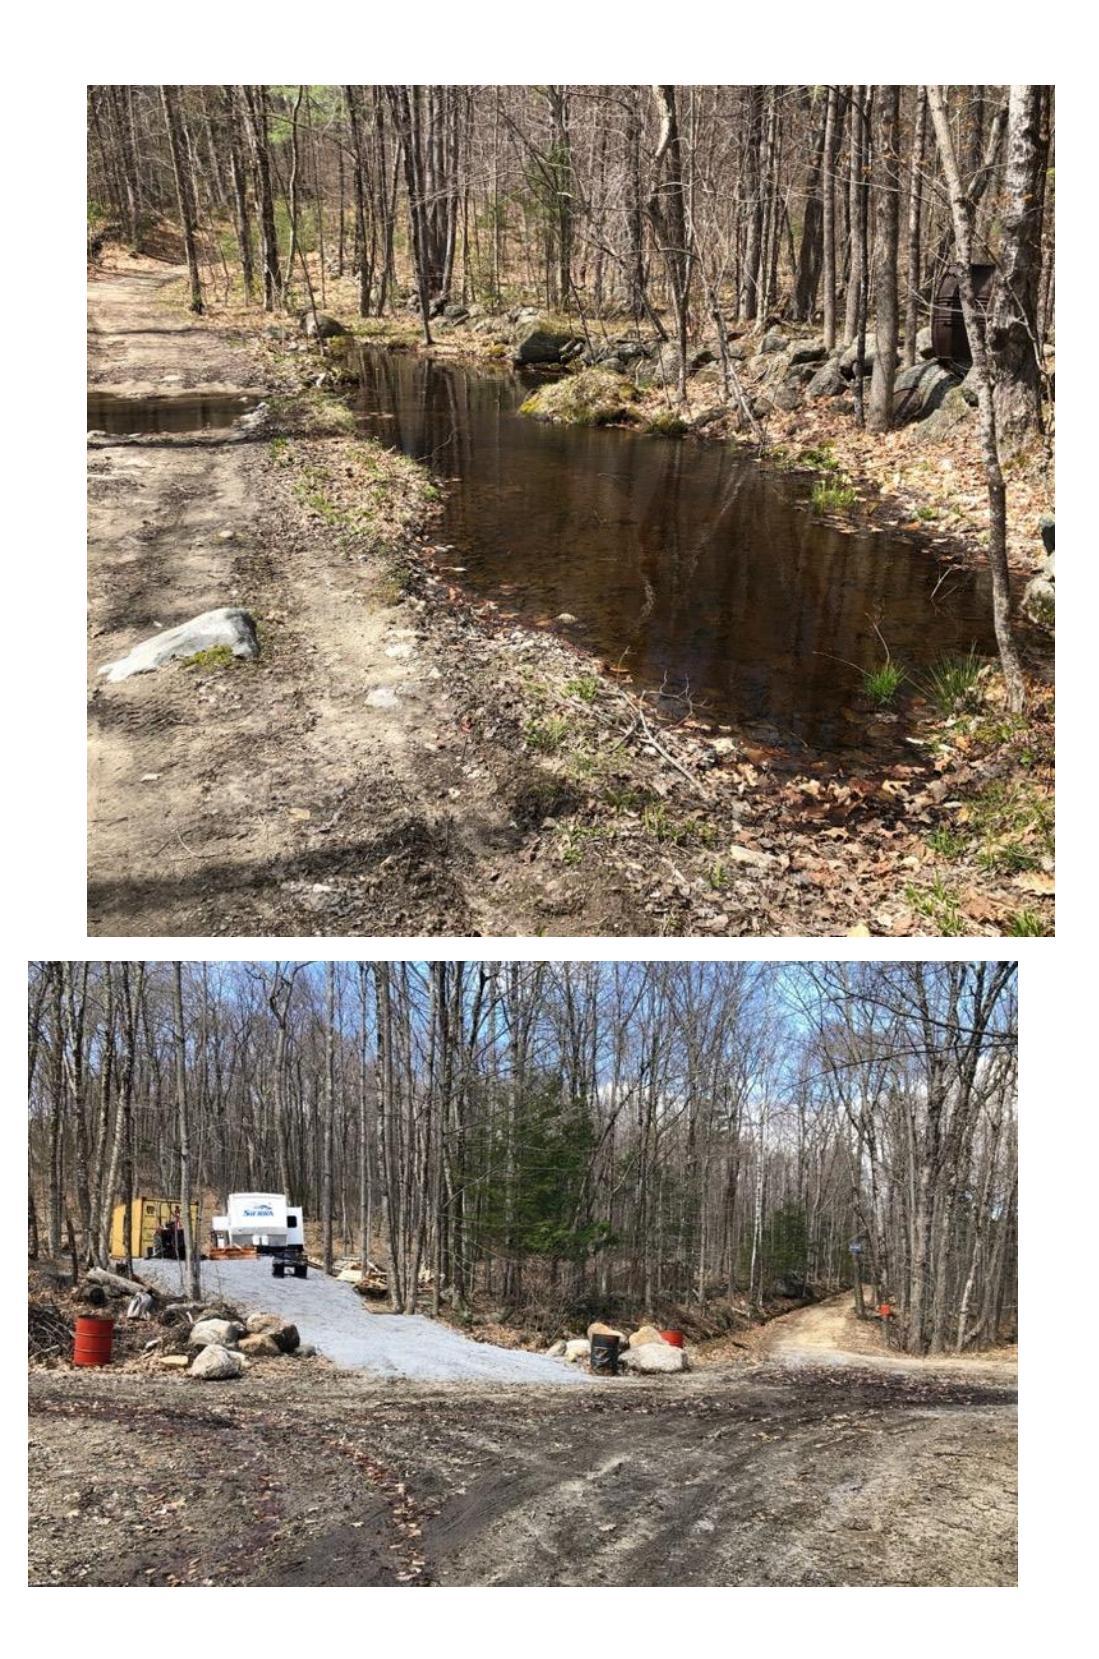
Erosion: Section closest to Rowe Mountain Road has significant erosion and rocks appear to be getting higher. Riprap placed on Liberty Hill end makes road a bit more stable, though erosion continues. Evidence of previous off-road ATV "mudding" on North side of road appears to be returning to more natural condition (see pic).

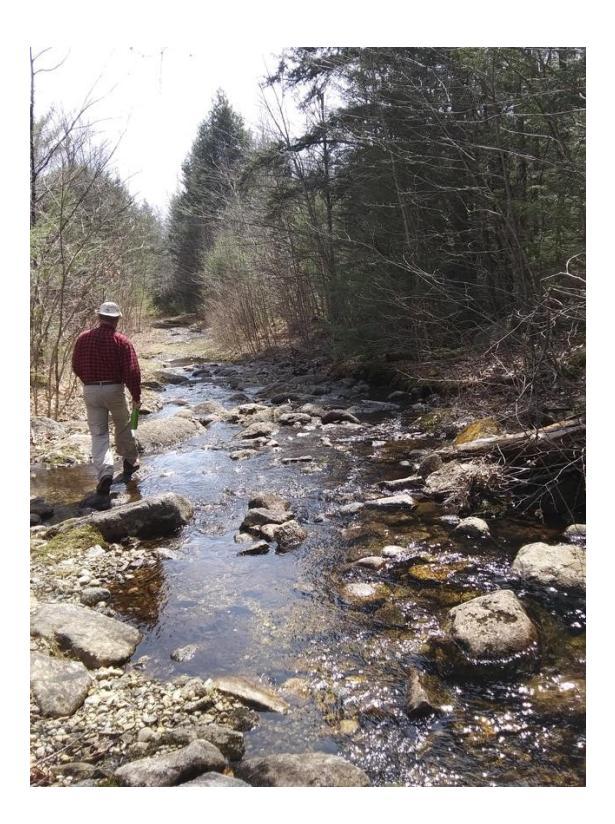
Erosion: Erosion continues in two sections of the road where the stream bed is the road. Road mostly Fair with two Poor sections. No evidence of recent usage by wheeled vehicles.

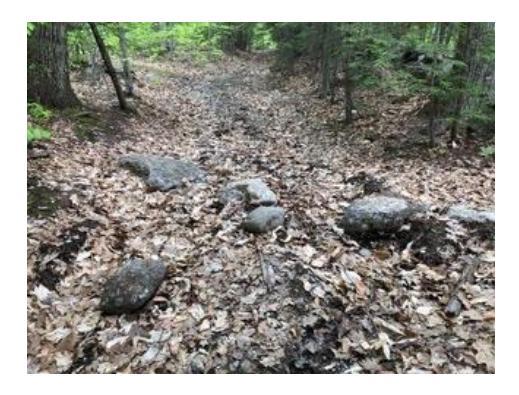
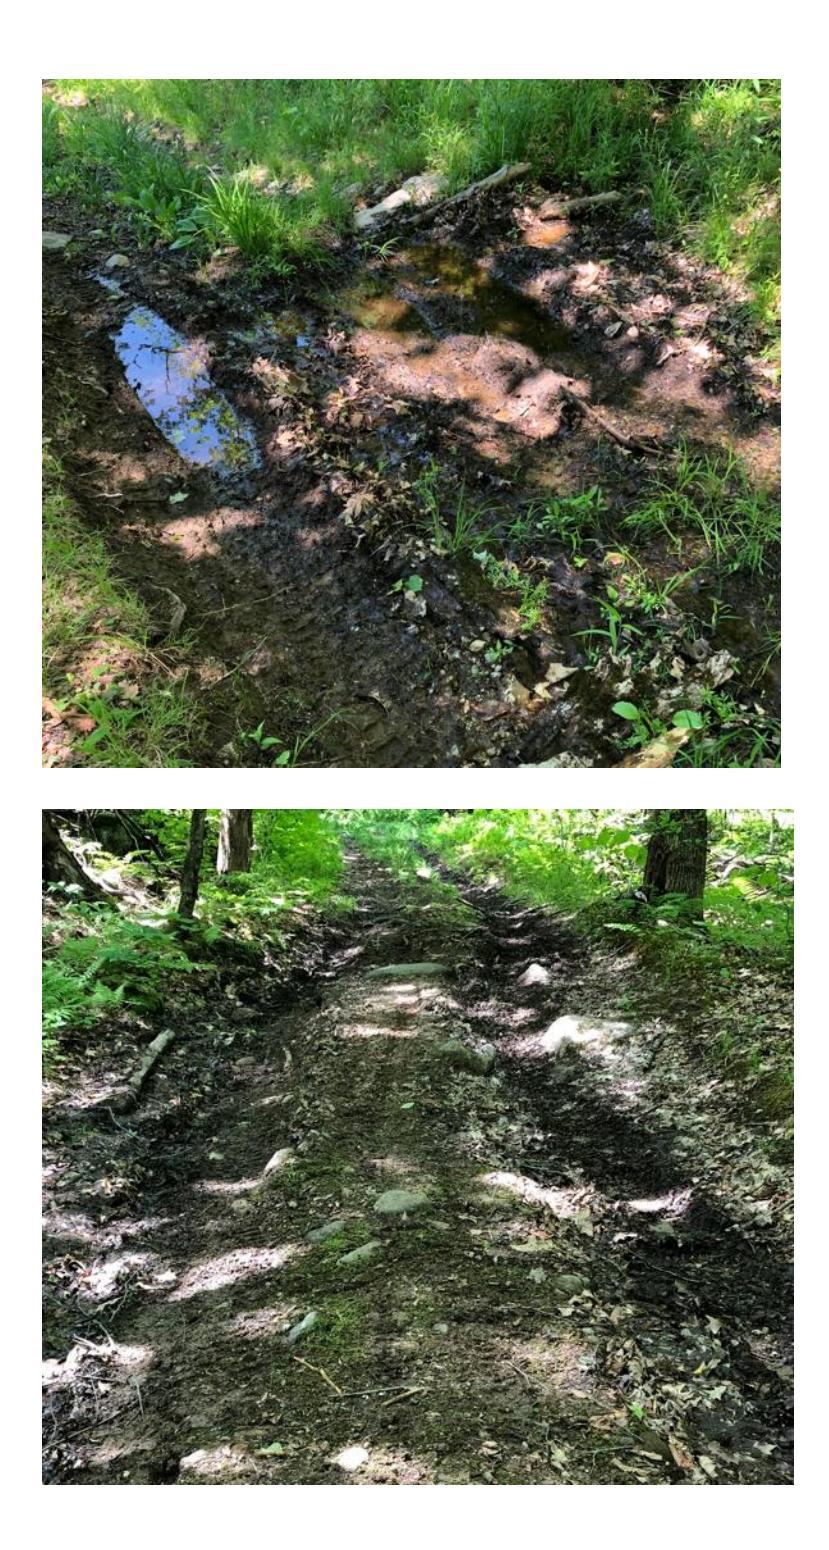
0.00 Initial section is Fair with some erosion. Water bars continue to do a good job. The first one has had a few rocks pushed out. Photo below.

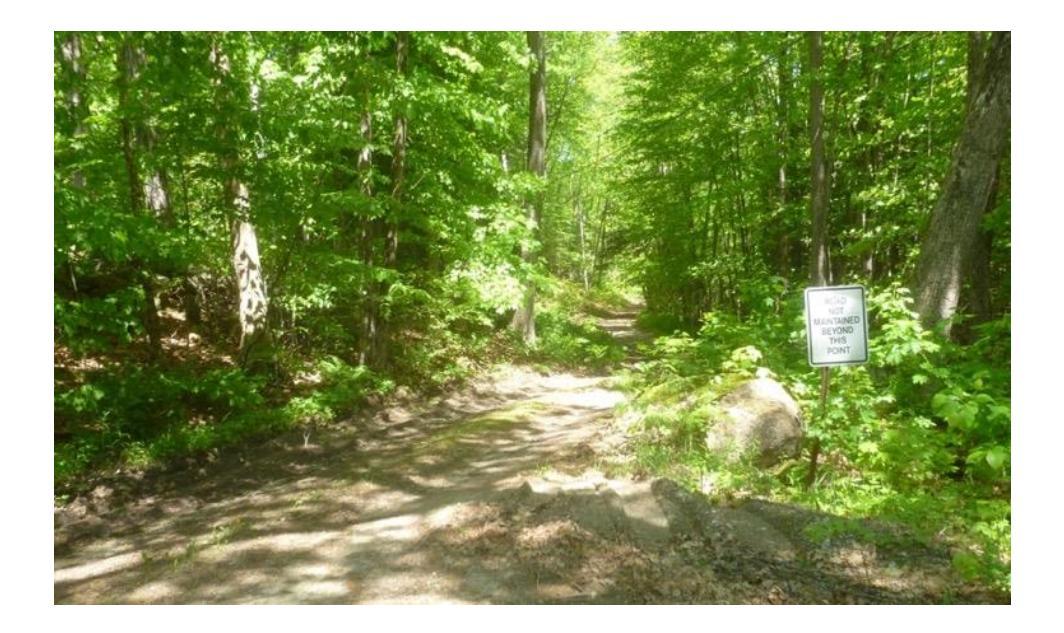
Erosion: Yes, in multiple places, notably around the driveway to 243. Overall, the road is "GOOD" with the exception of these mud holes.

Other Conditions: George Beaton did some grading with this tractor in 2021 to fill in some of the mud holes/ruts.

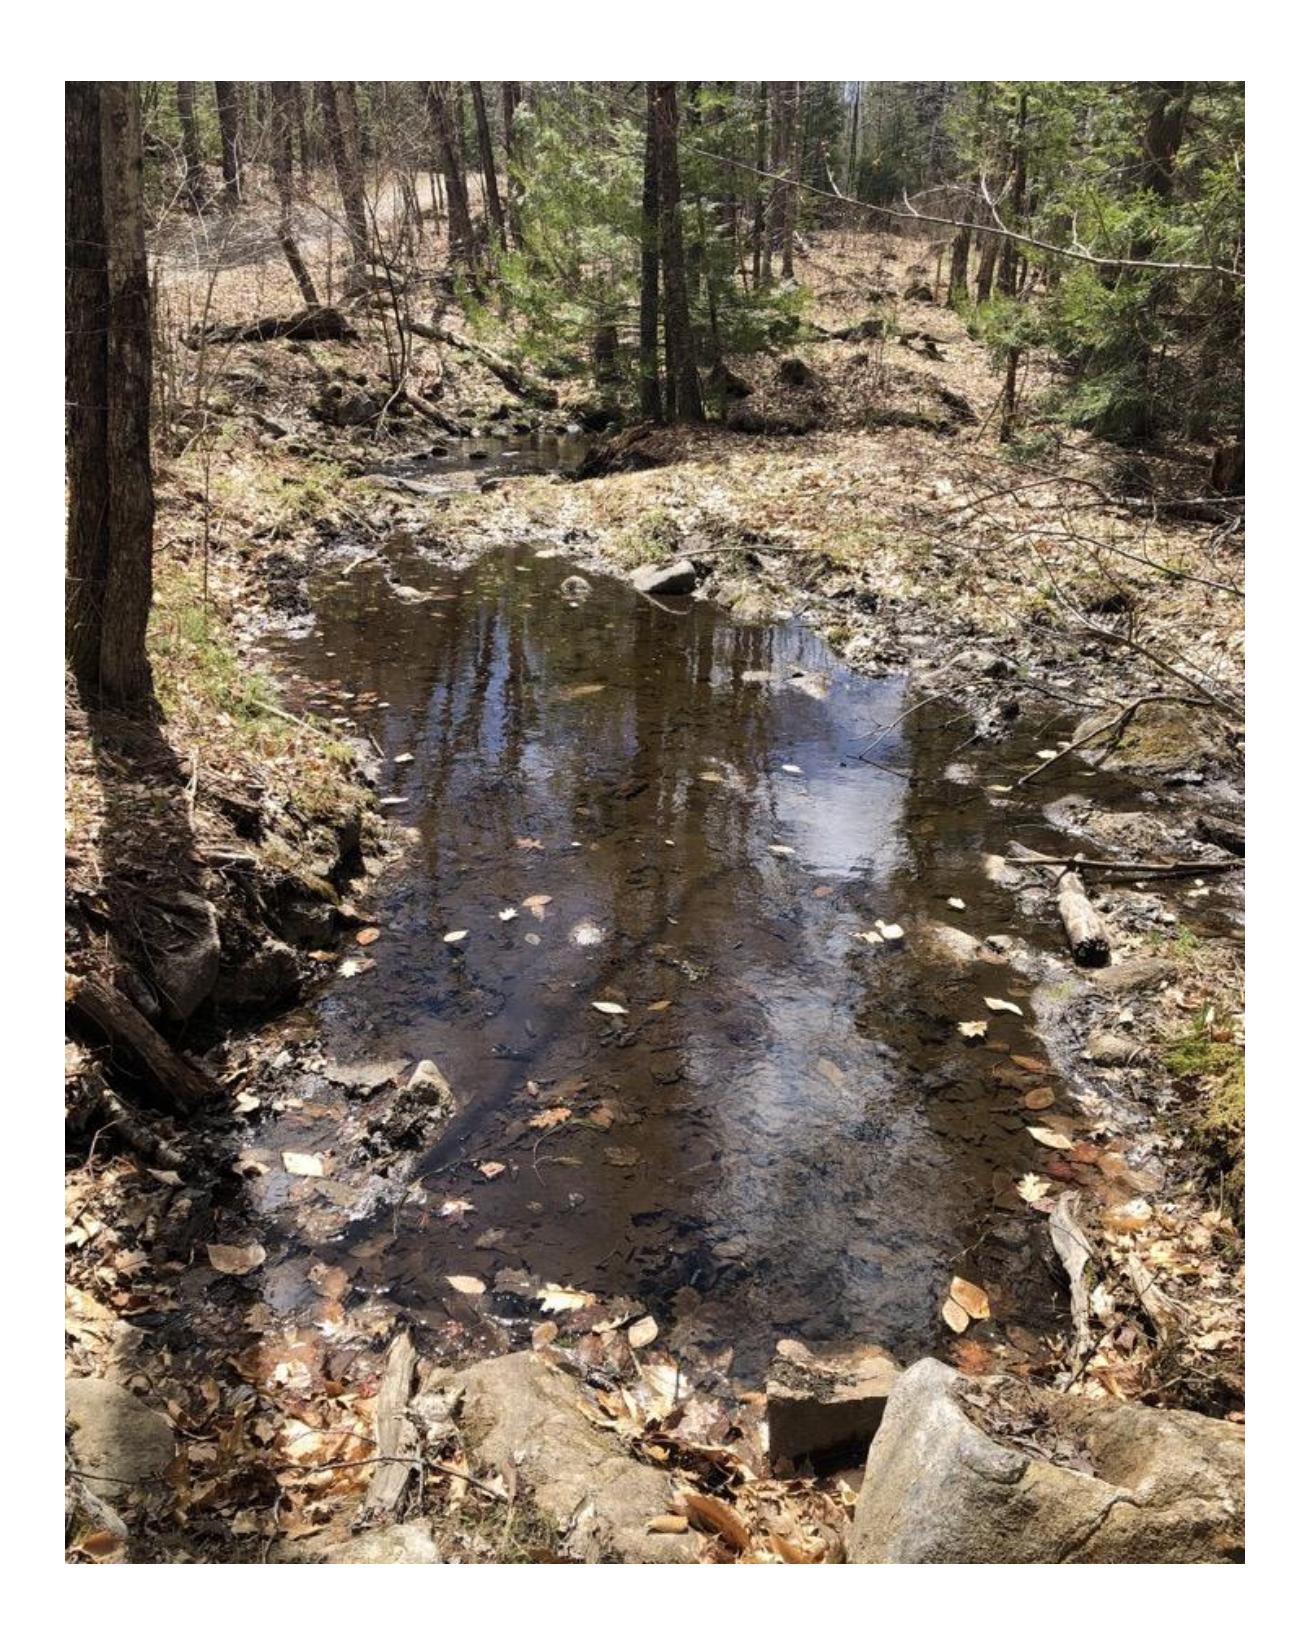
Erosion: Section closest to Henniker has significant erosion. Multiple large mud puddles encountered with vehicle tracks extending the road on both sides. Crushed rock placed on Bradford end makes a more stable surface for the road. Off-road damage next to bridge appears to be healing with no sign of recent ATV "mudding".

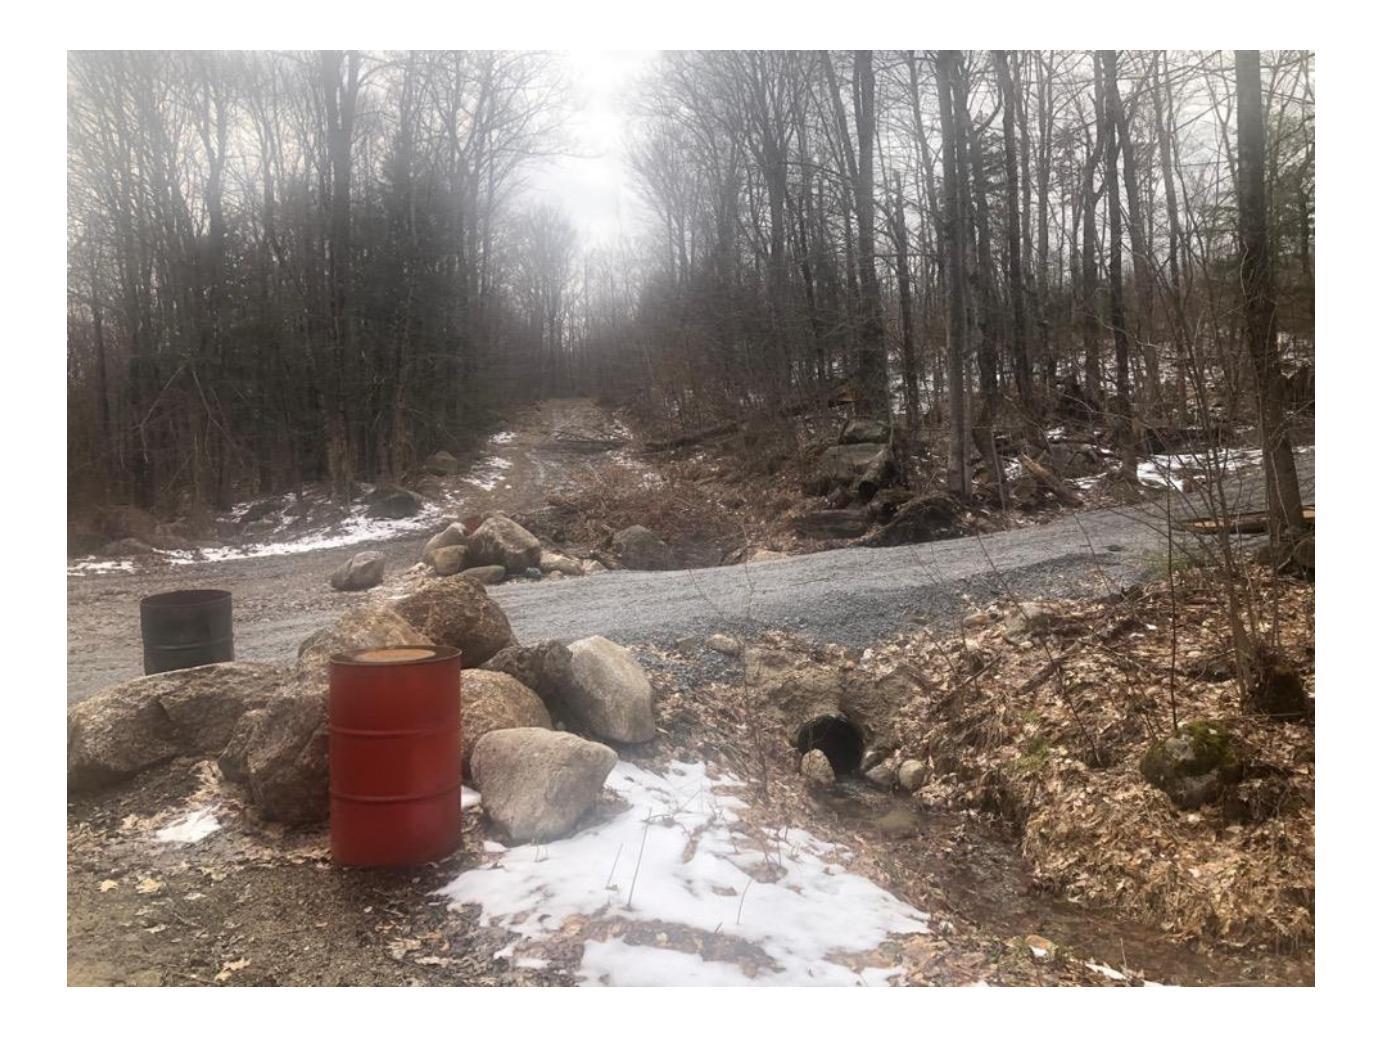
0.8 Road in generally Good condition with isolated rocks and water bars. Relatively fine gravel has been added in several places. However, traffic has created a washboard effect. In addition, several water bars are quite deep.

Erosion: Washboard surface in places and deep water bars. However, these improvements seem to have limited overall erosion.

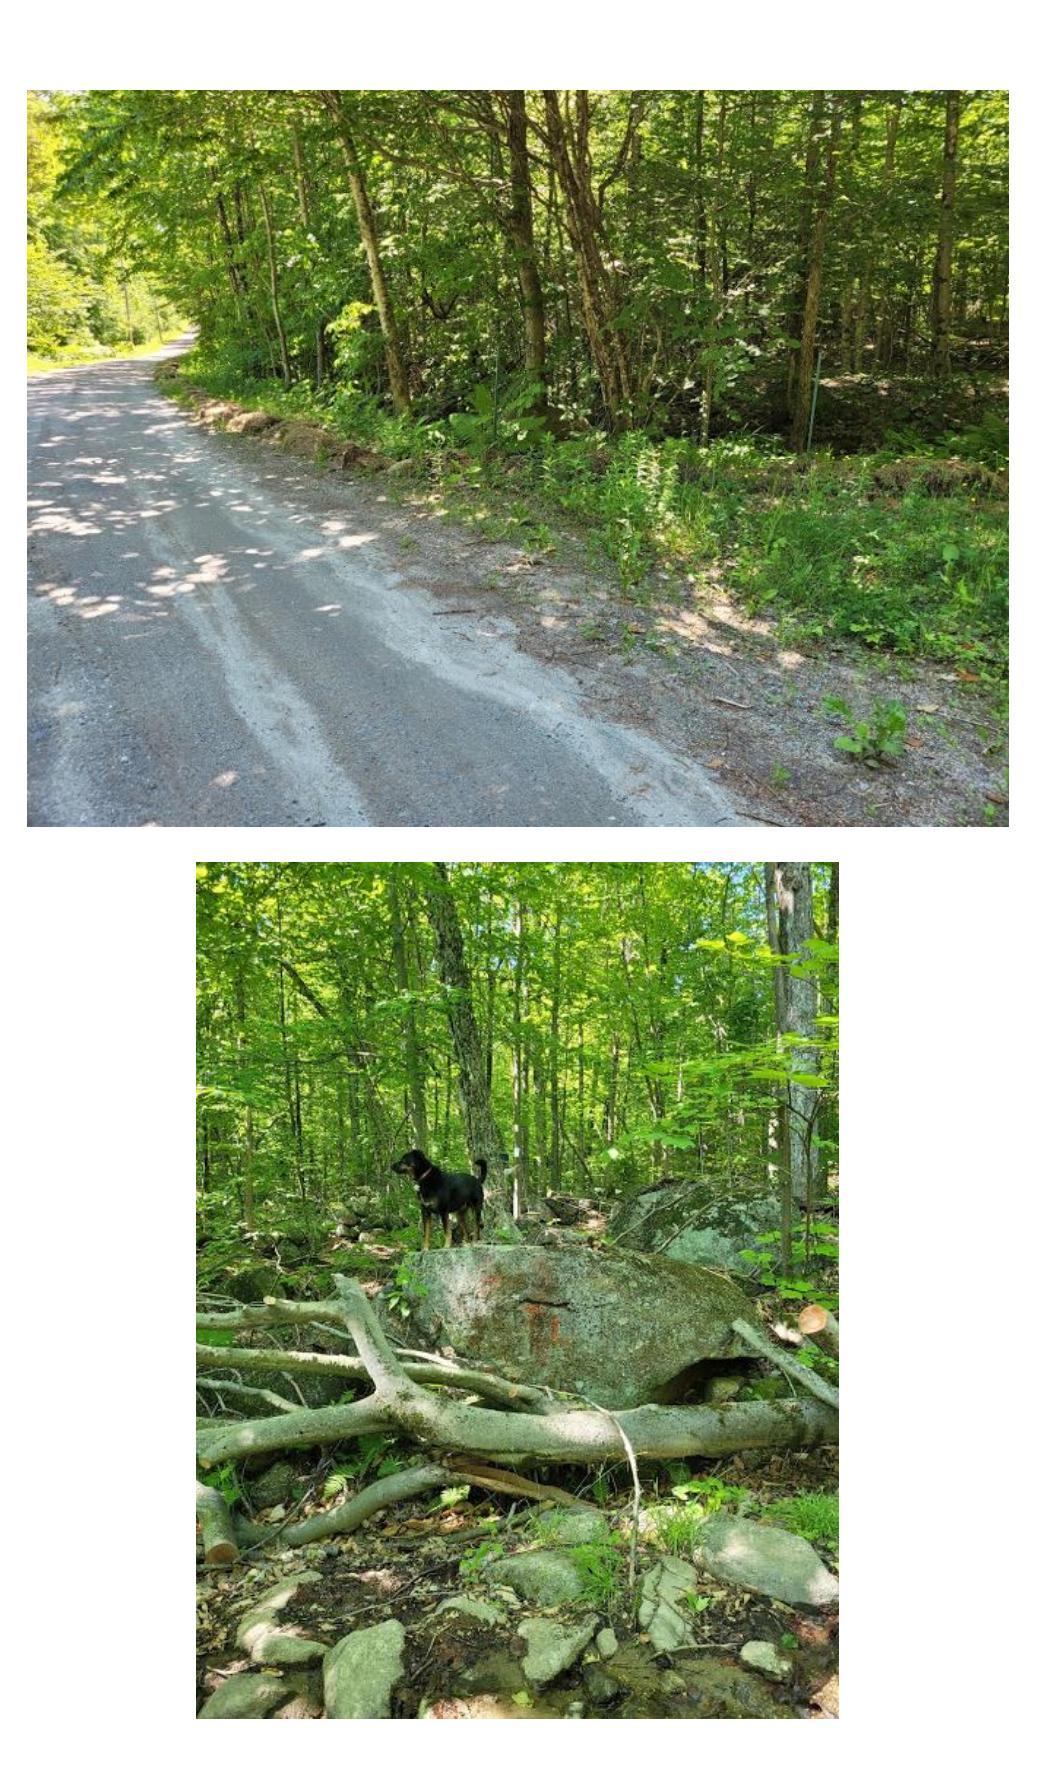
We found conditions to be significantly the same as the last report. No new issues of concern were identified. Town line located (see pic with dog).

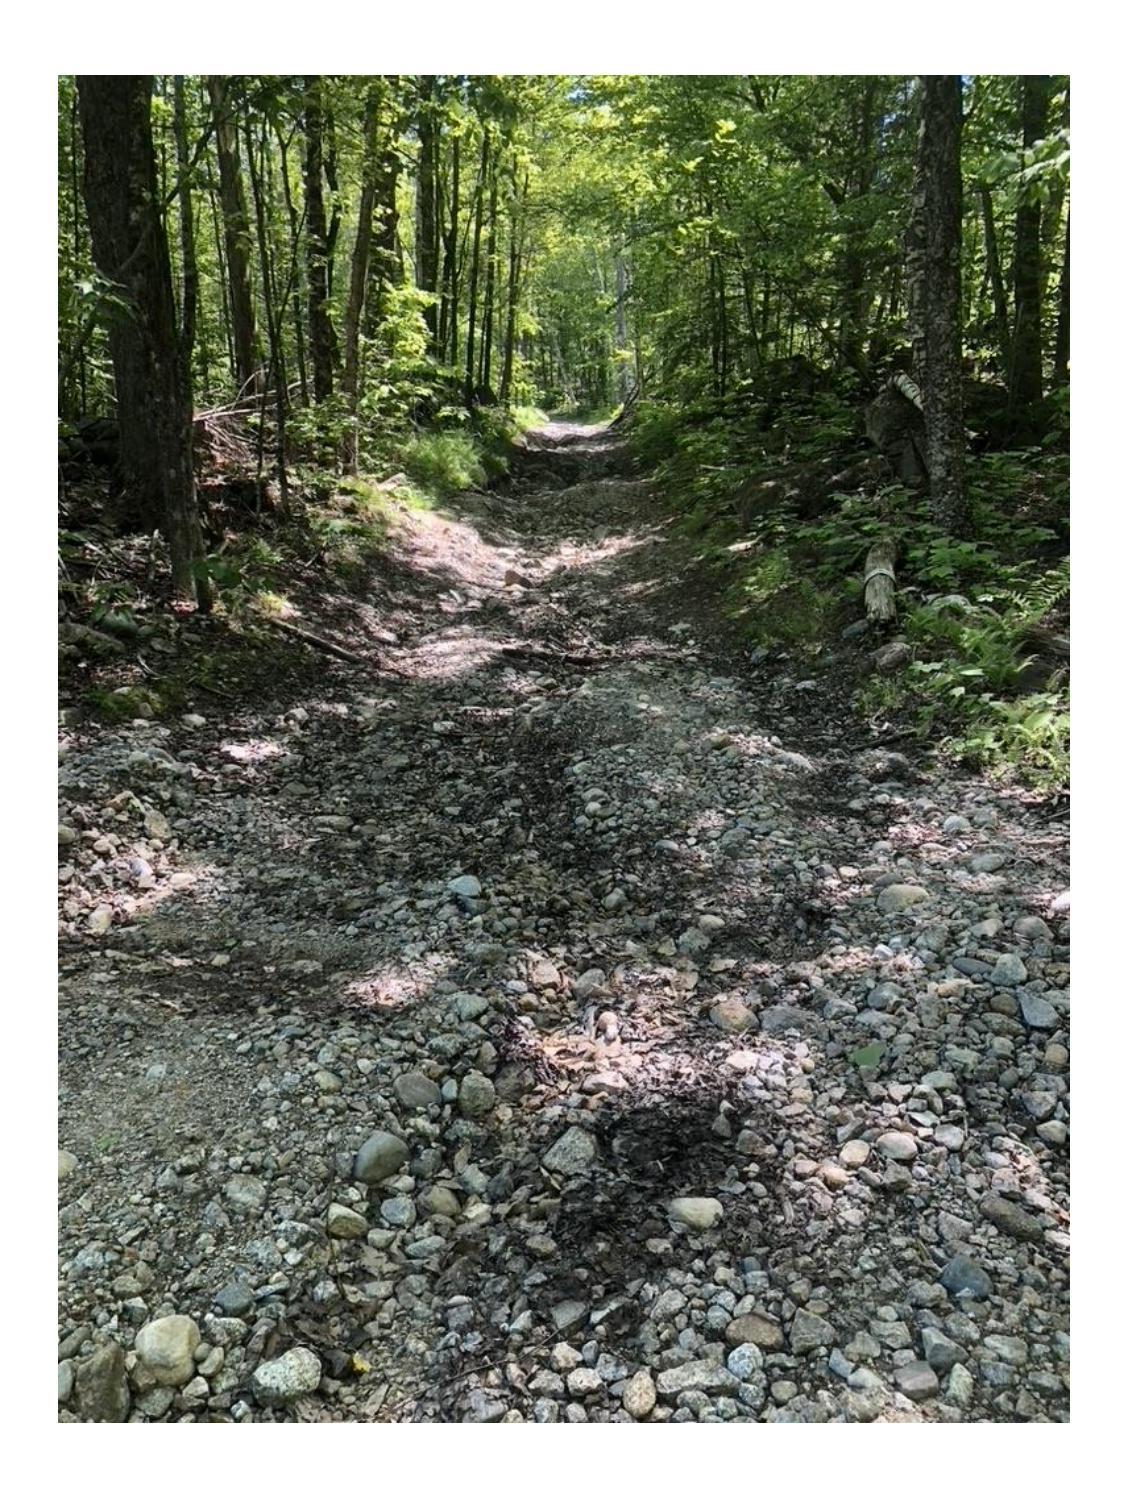
- 0.0 Road initially level and then climbs up a significant hill. Overall road condition in the first 0.1 miles is "GOOD" due to crushed rock being laid associated with a timbering operation. From 0.1 miles to 0.5 miles the road appears only "FAIR" as the crushed rock was minimal compared to the first 0.25 miles. Significant erosion occurred during the July 2021 rain storm (see picture). Snowmobile trail off Southard property enters at about 0.15 miles.

Erosion: Entire road suffers from erosion, however, the section from 0.75 to 0.94 miles is extremely eroded. Rocks/ledge drops of 1-2 feet are frequent in this section. Significant erosion in first 0.25 mile is new since July 2021

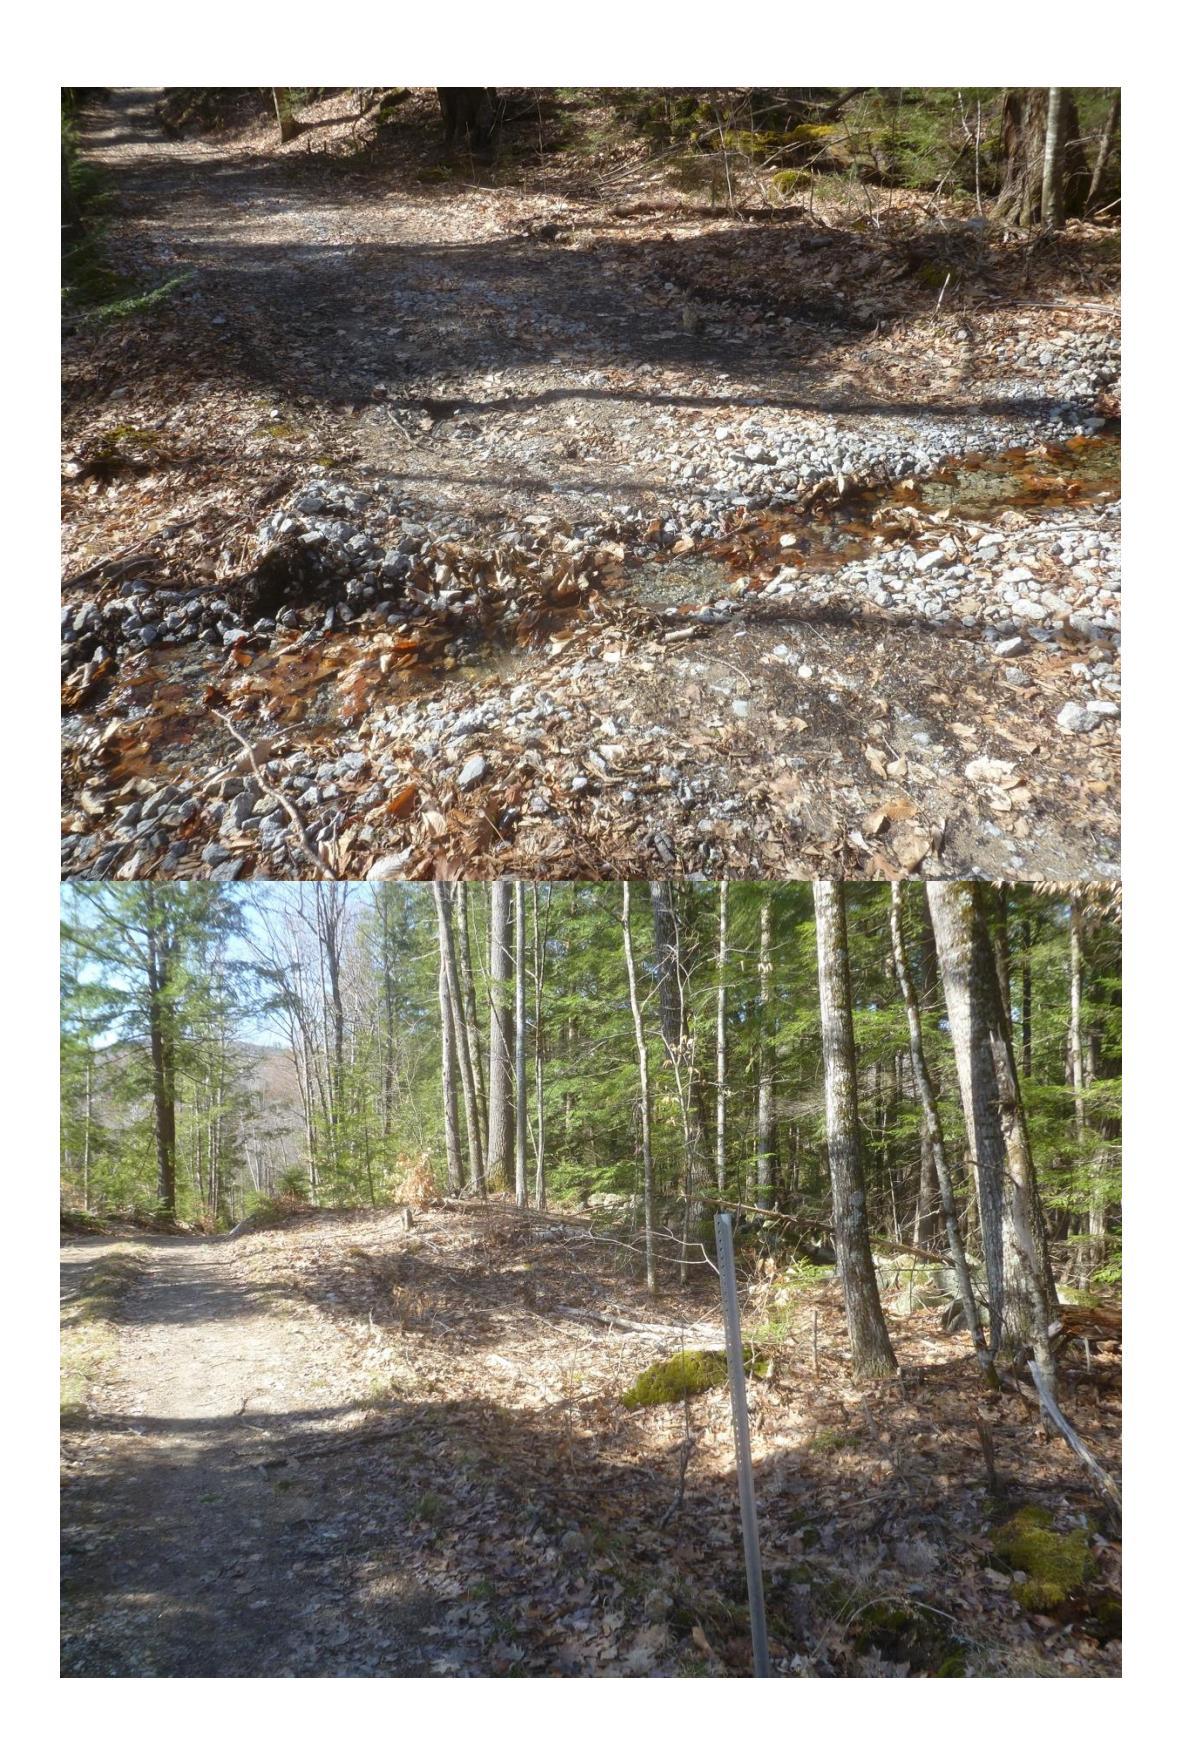
Erosion: Since the last monitoring in May 2021 logging has impacted the stretch of road from Forest St to the Smith cellar hole. Stone has been brought in and 2 water bars have been created which has helped in those areas (see pics). The Road closure sign is missing at Forest St end and there is a new washout about 300 yards in from Forest St.(see pic) This periodic flooding across Smith Rd was first noted last November and reported to the road agent along with the missing sign. From the Smith cellar hole up to Rowe Mt road the condition has not changed much from last year.
