# *Adopt a Road*

## Bradford Conservation Commission Summer 2025 Report

## Summer 2025 Update

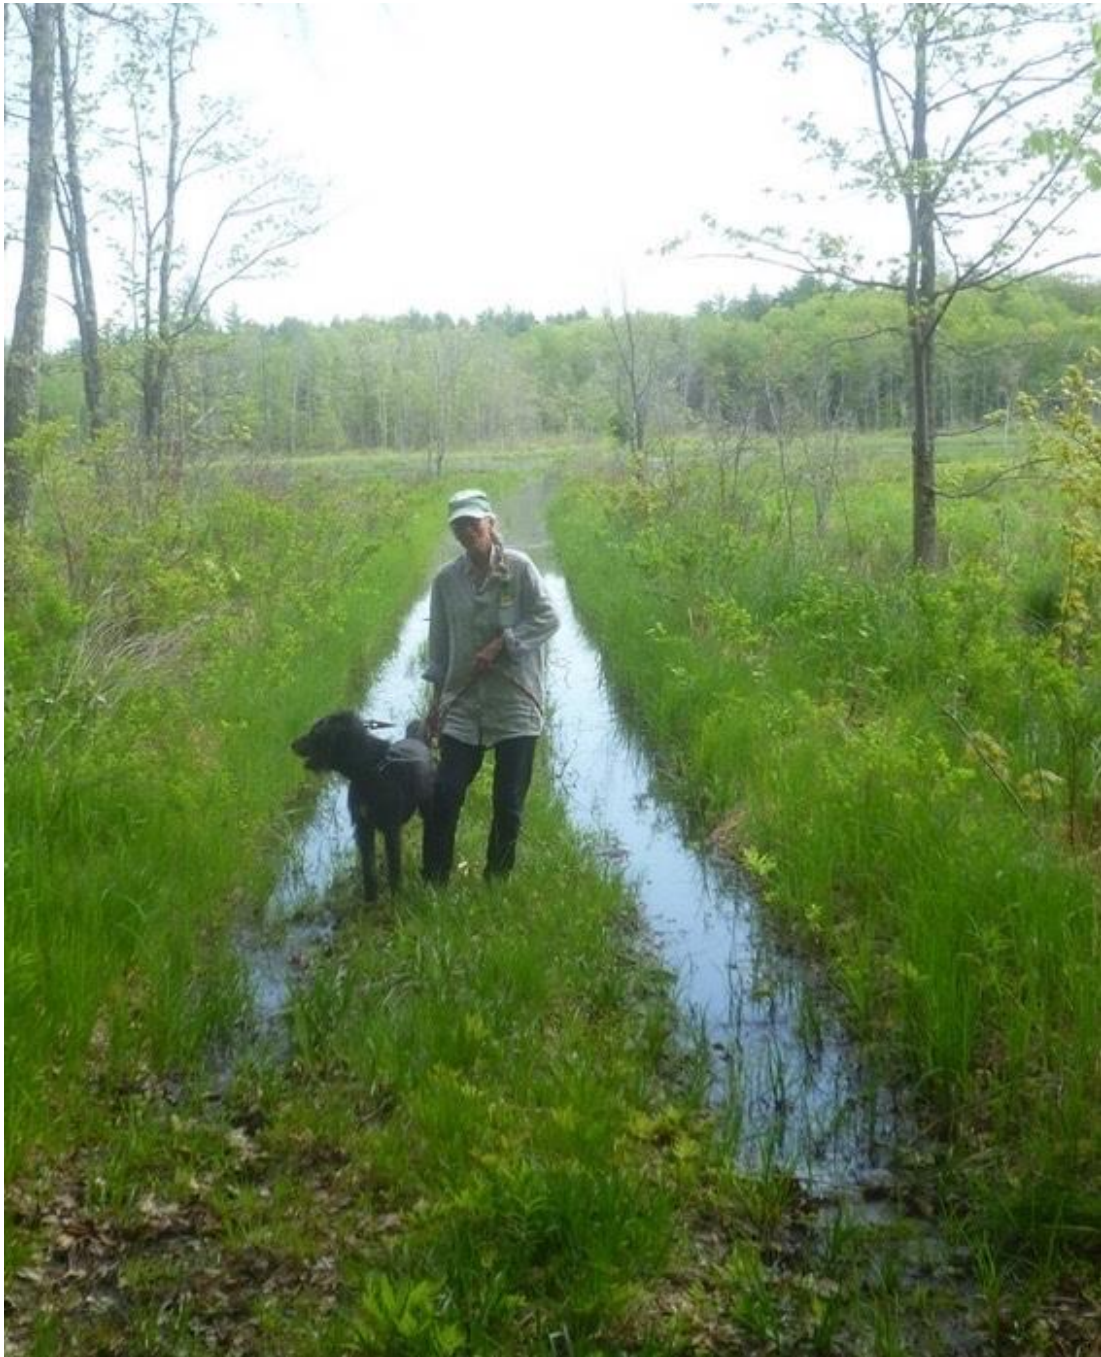
<u>Miles</u>	<u>Conditions</u>
0.25	Up until this point, road is in GOOD condition with placement of crushed rock. A small building is encountered on the left side of the road which appeared to be occupied in the past. Numerous junk piles and cars/trucks along-side of the road.
0.75	Road surface is FAIR to GOOD, reasonably flat, but with significant mud puddles. One culvert juts up from the road surface.
1.0	Road continues to be in FAIR to GOOD condition, but ends in water at approximately 1 mile (see pic).

0.1 miles	Road is reasonably flat and in FAIR to GOOD condition with mud puddles. Road ends in water as was the case from the entrance via East Washington Road.
Erosion:	Modest amount of erosion as the road surface and surrounding land are relatively flat. However, there are numerous mud puddles. No significant changes to the road condition from 2022.

Obstructions: No problem for emergency access except for the permanent flooded section of the road close to County Rd.

*Submerged Section of Alder Plains Road 2022*

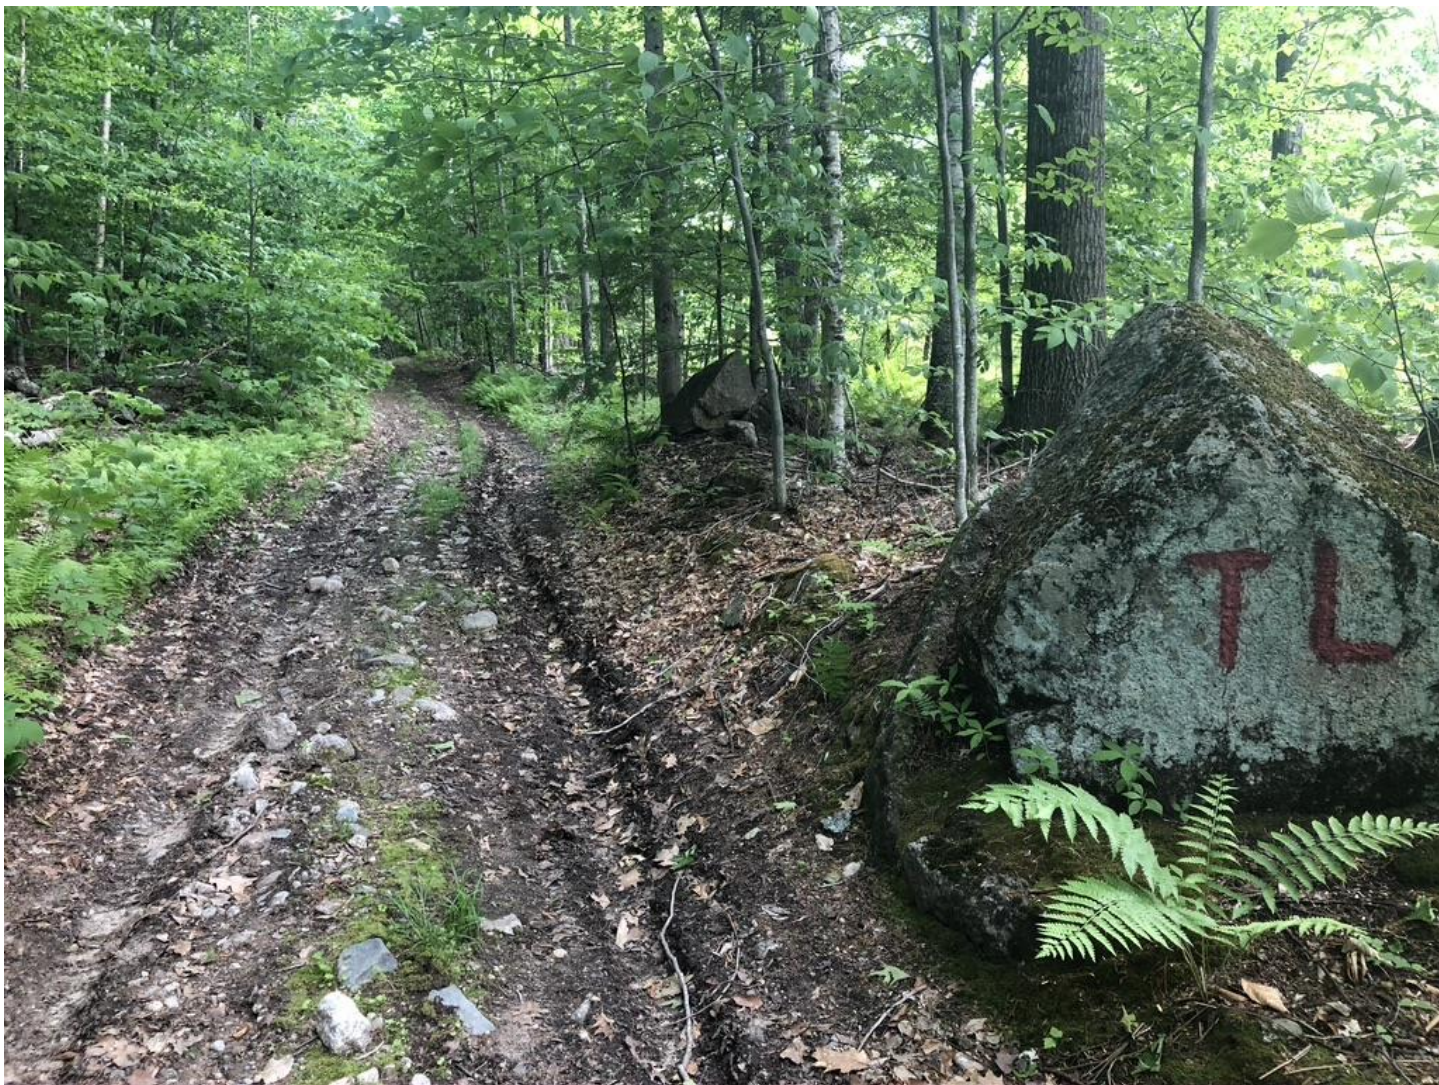
*Spring 2020*

Erosion: Mud/pot holes with some large rocks noted on the unmaintained section.

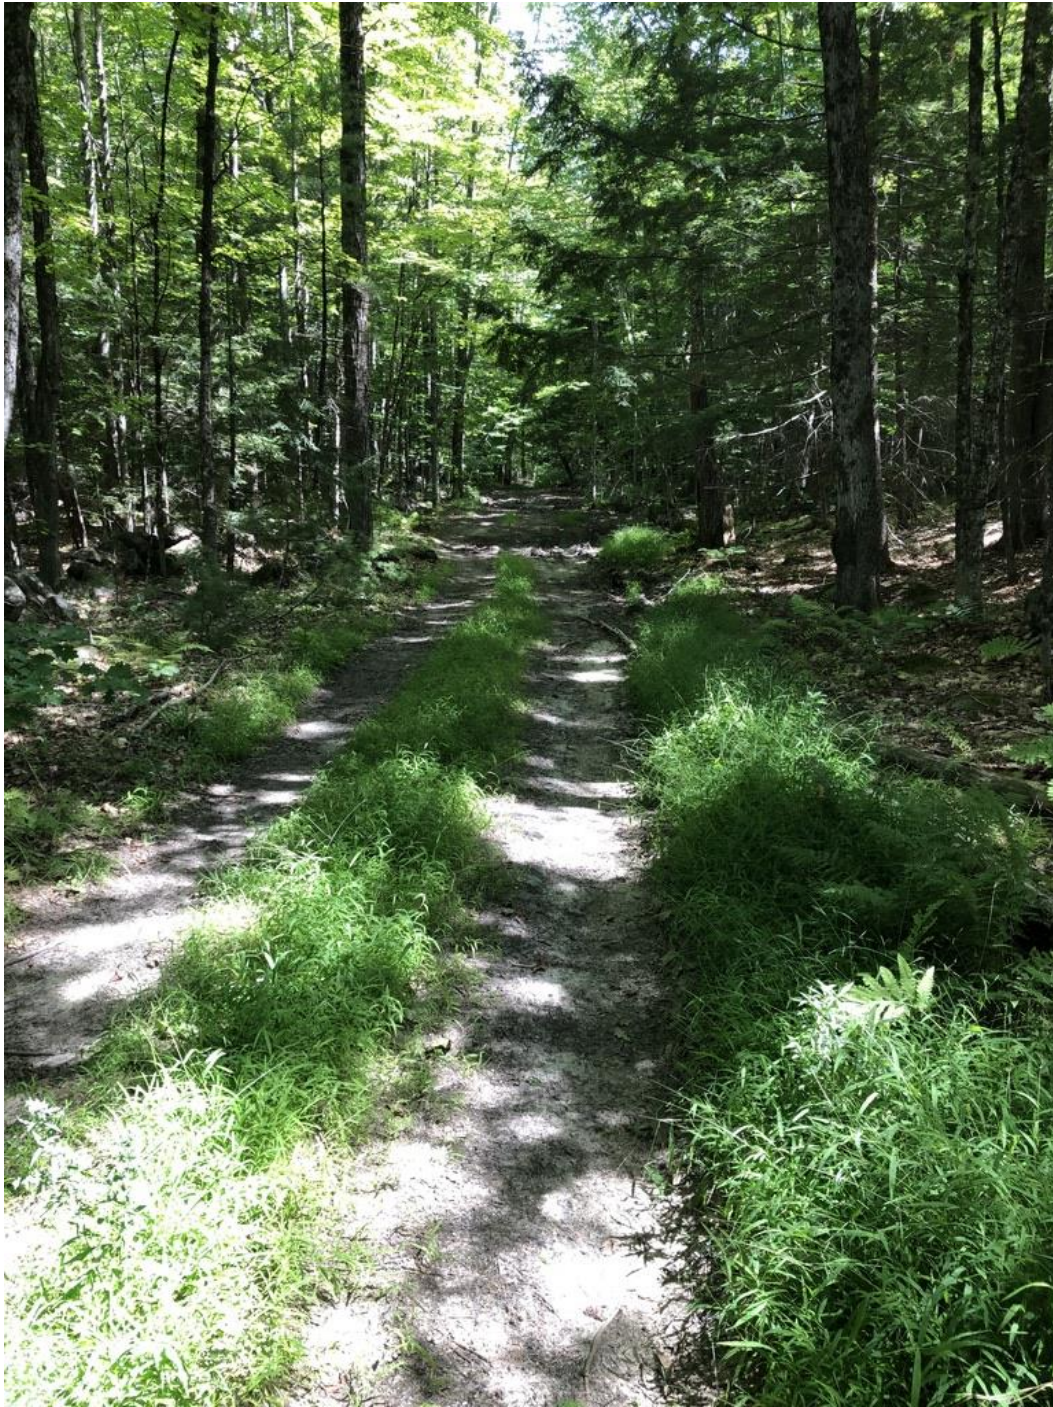
*Spring 2022*

Erosion: The road is a gravel moderate upgrade, with significant rutting in the first 0.1 miles, due to vehicular travel in the past, and now exacerbated by erosion from rain events. Large rocks are exposed in the road in several areas. The road grade lessens, and continues to the presumed town line, after which it has many areas of flooding due to previous logging activity.

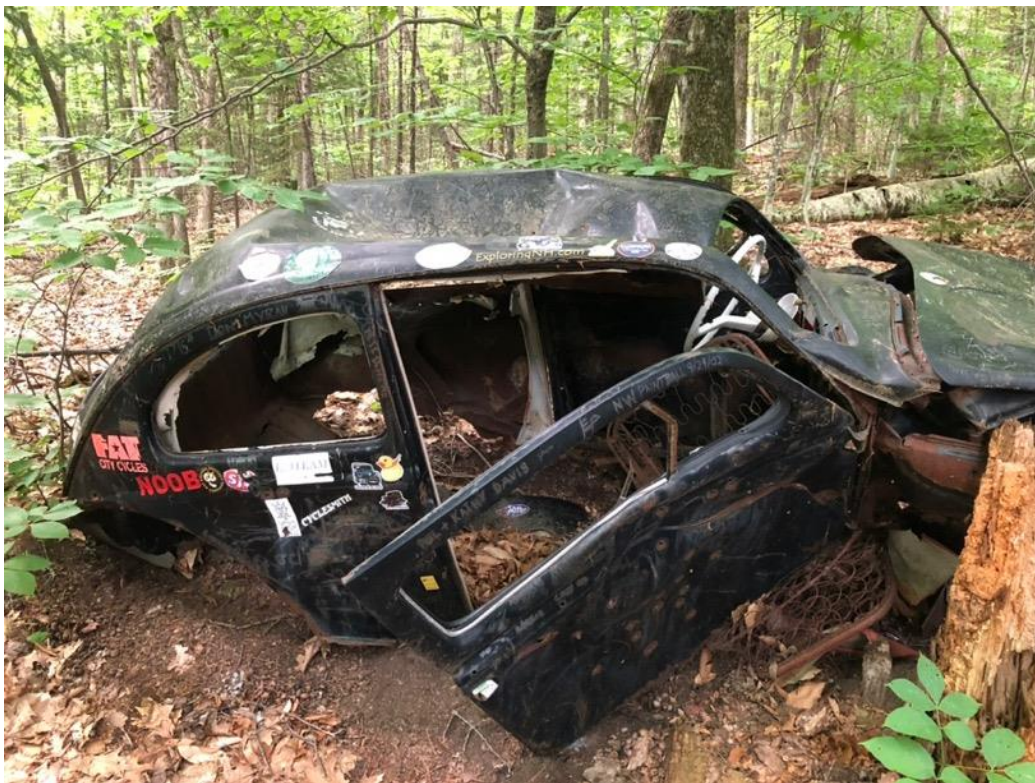
Trash/Dumping: Some trash and an abandoned car.

Motorized/Non-motorized Activities: Significant tire tracks, including ATV and 4x4 truck\jeep. Abandoned vehicle noted at top of hill.

*Abandoned Car on Carter Hill Road: 2024*

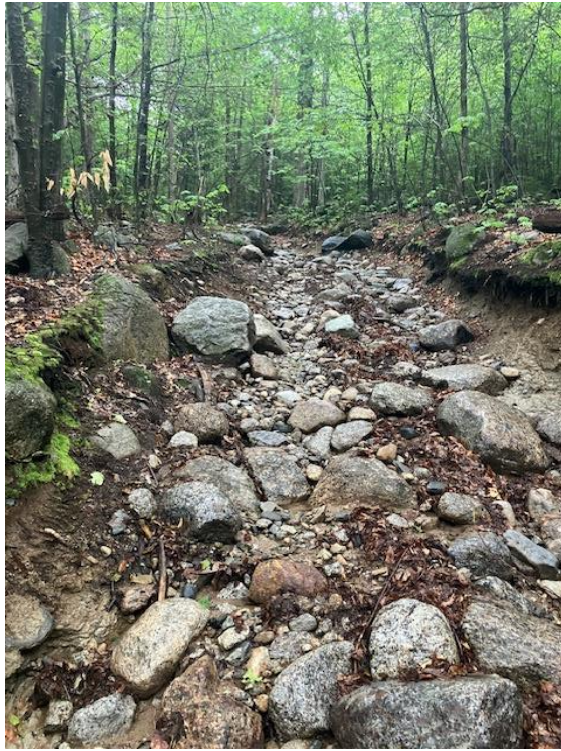
0.0 - 0.17 miles: Road climbs steeply uphill immediately from Day Pond/Massasecum Ave./Rowe Mt. Rd. junction. Road condition is FAIR to POOR, mostly exposed rock with some sandy areas.

0.6 - 0.75 miles: Road climbs steeply, extremely eroded, no soil present, small stream running down. Road condition extremely POOR.

*Carter Hill Road Rocky Section 2025*

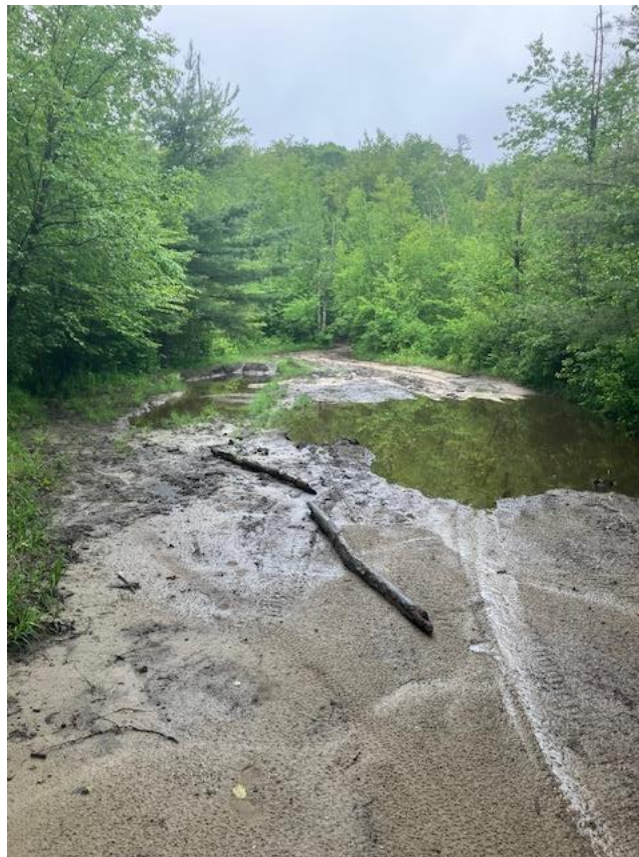
0.55 - 0.6 miles: Large, moderately deep mud wallow, "2' deep, about 30' x 50' in diameter.

Obstructions: One low lying area has roughly 6 inches to 2 feet of muddy water, perhaps 50ft by 30ft (see picture). Mud hole hasn't seemed to increase in size, but another bypass has been cut through the low-lying forest to allow ATVs to pass. The cut section is too small for Jeeps. \*FIRST RESPONDERS: the mud wallow (.5 miles), the large tree root (.74 miles) and the impassable section (.57-.64 miles) immediately following the mud wallow would most likely prevent anything but a very large vehicle with very large tires from getting through.

*Carter Hill Road Mud Hole Tracks 2025*

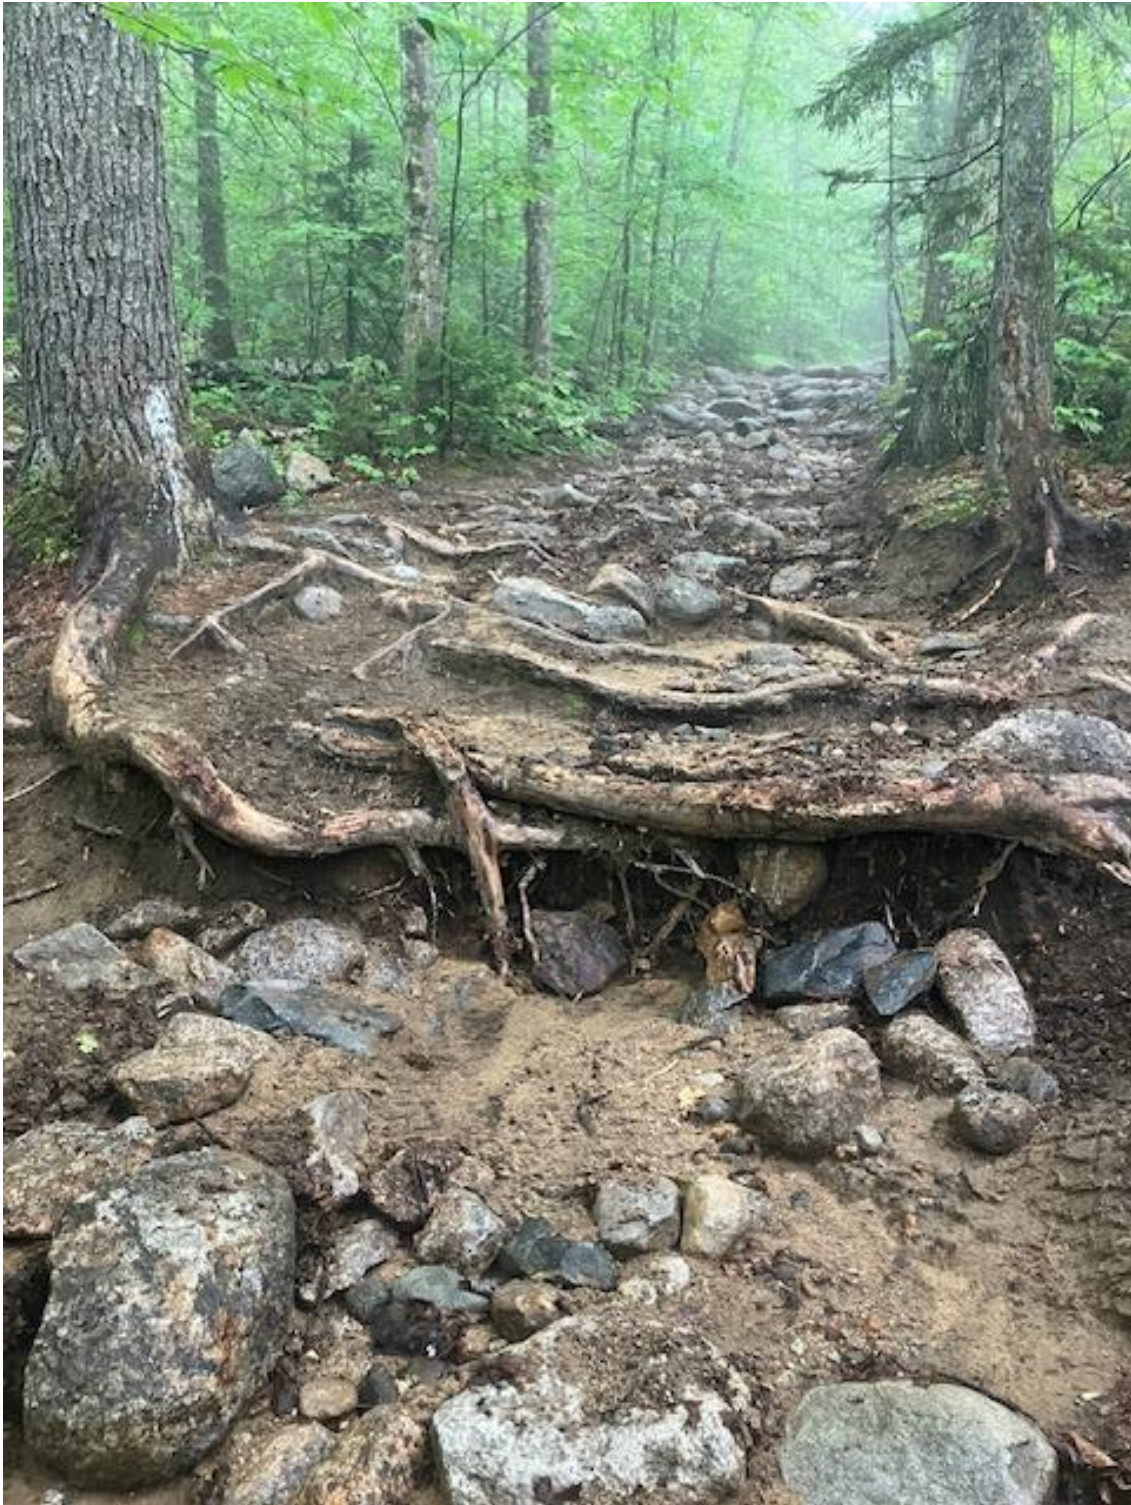
*Carter Hill Road Obstruction 2025*

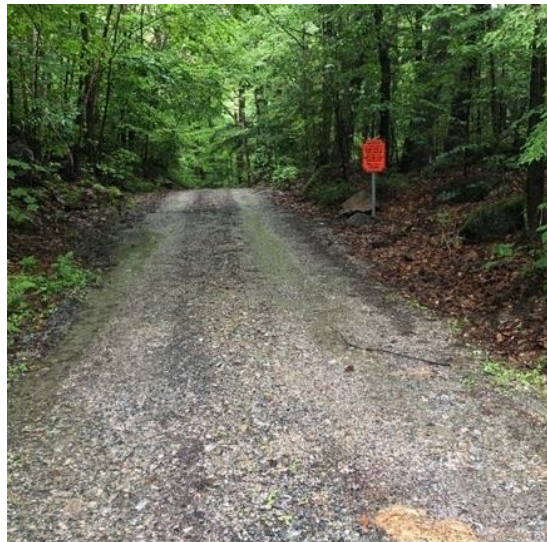
*County Road 2021*

0.37 Road maintained by local residents and is in EXCELLENT shape for a Class VI road, although somewhat of a single lane due to wetlands on both sides.

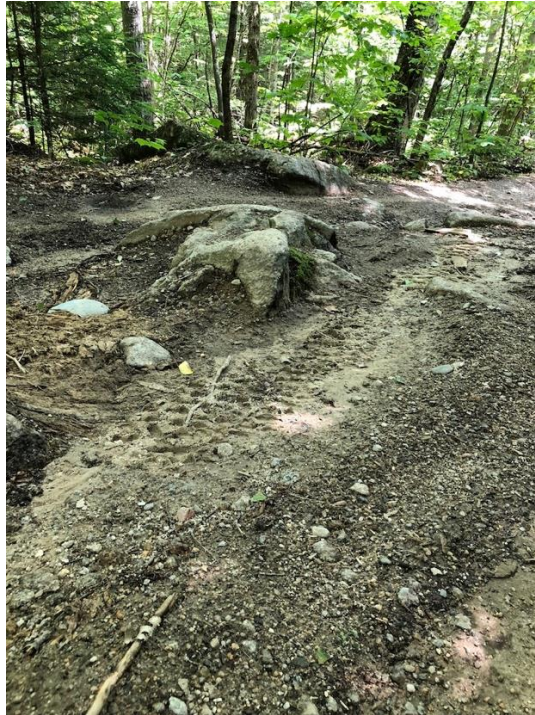
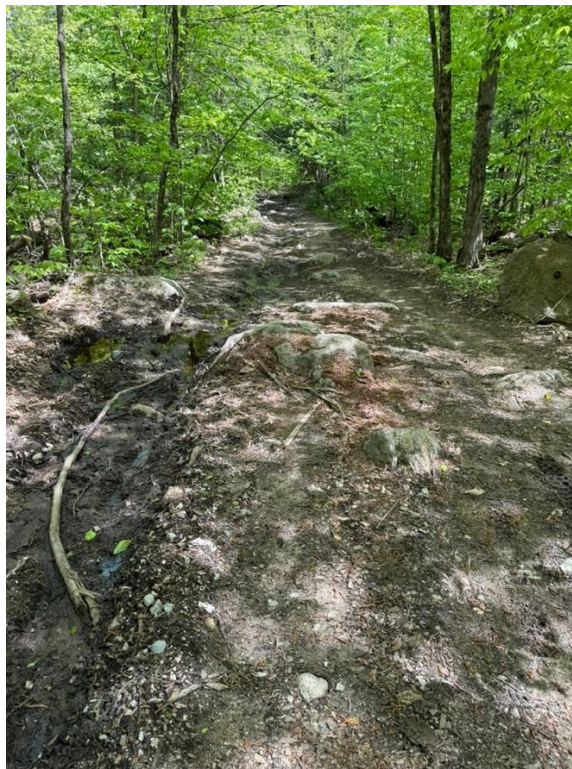
*Day Pond Road: 2018*

- 0.0 Road generally in FAIR condition with some large rocks (8-12 inches) over the first .25 miles. Monitoring of May 2025 finds that the height of these rocks appear to be increasing as was the case last year.
- 0.37 Appears to be old off-road damage near a water crossing on left (North side).
- 0.7 Culvert is significantly washed out. First noticed 2025. (see pic)
- 0.96 Road enters 4-way junction with Liberty Hill Road and a private road before continuing on to Rt. 114. The last .25 miles moves from FAIR" to "GOOD in sections due to crushed rock placed during logging operations. Some deterioration of these upgrades was noted in July 2024.

Erosion: Section closest to Rowe Mountain Road has significant erosion and rocks appear to be getting higher. Crushed rock placed on Liberty Hill end makes road a bit more stable, though erosion continues. Evidence of previous off-road ATV "mudding" on North side of road appears to be returning to more natural condition. Significant erosion noted to culvert at 0.7 mile mark.

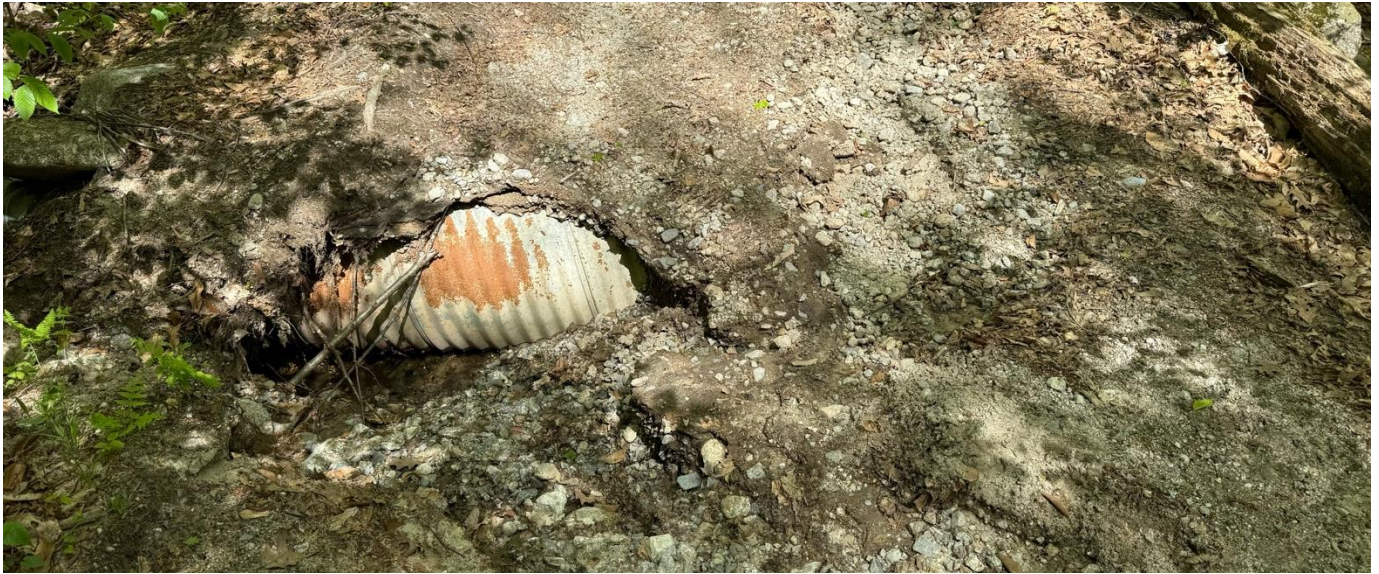
*Newly eroded culvert 2025*

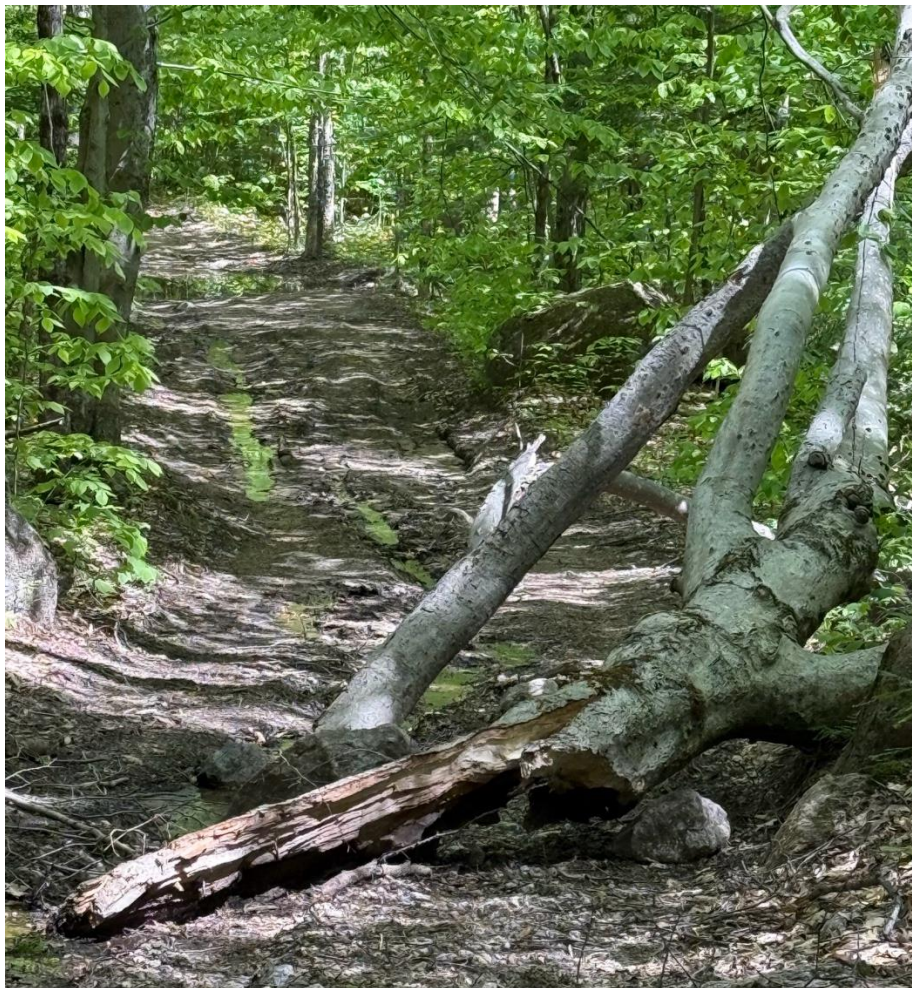
Obstructions: One large tree down and partially obstructing road.

*Partial Obstruction 2025*

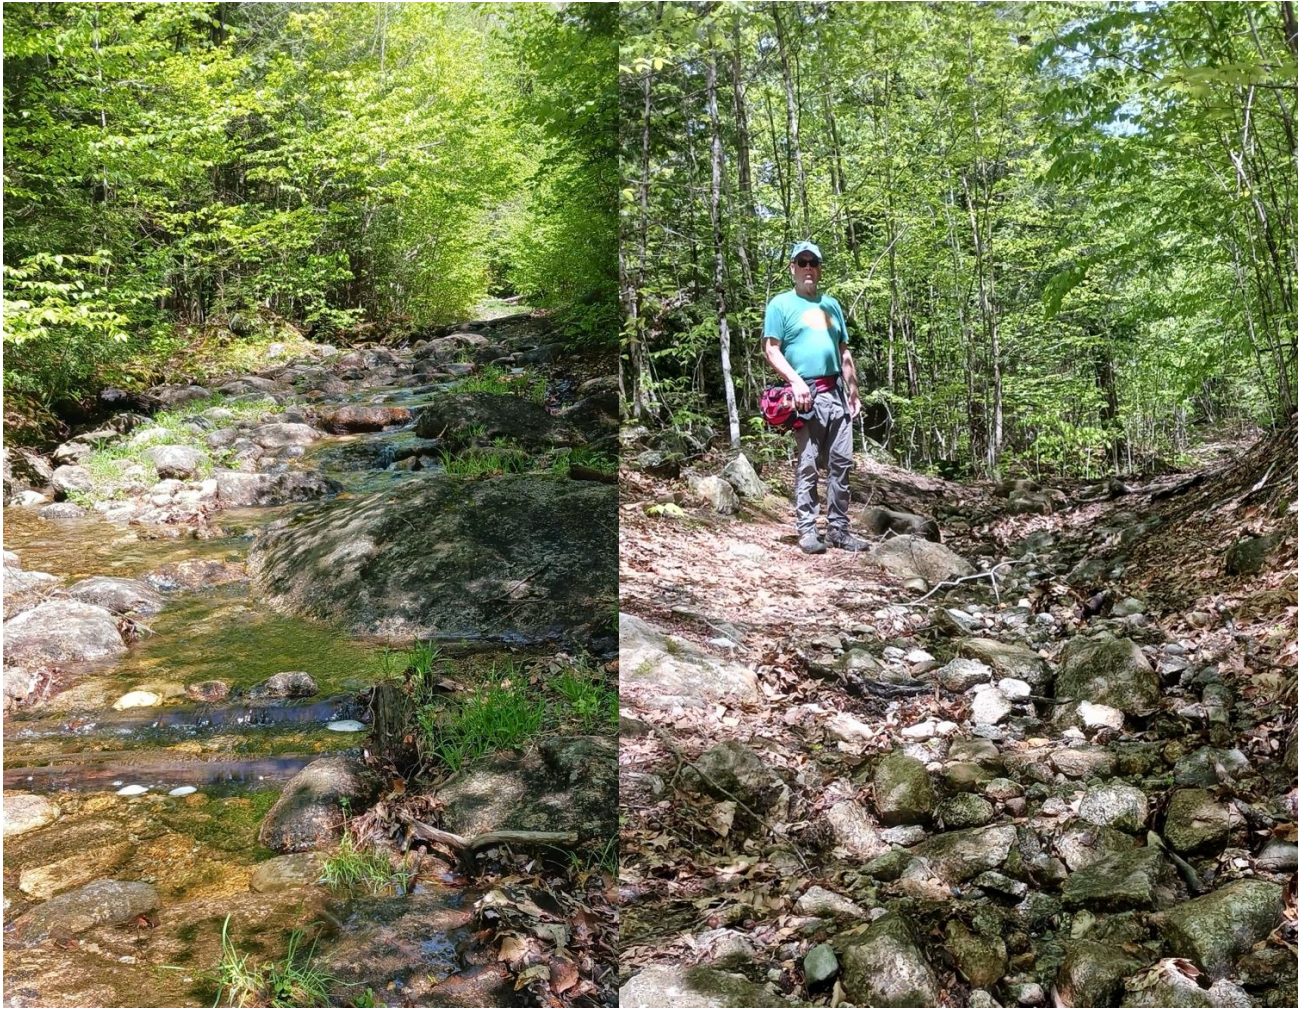
*Deer Valley Road 2025*

Erosion: Erosion has worsened in two long sections of the road where the stream bed is the road. A noticeable degradation from last year. Road mostly FAIR with two very POOR sections.

Obstructions: Gate at Bradford end closed but not locked. The increasingly eroded sections of the road may not be passable for the Fire Dept. Gator.

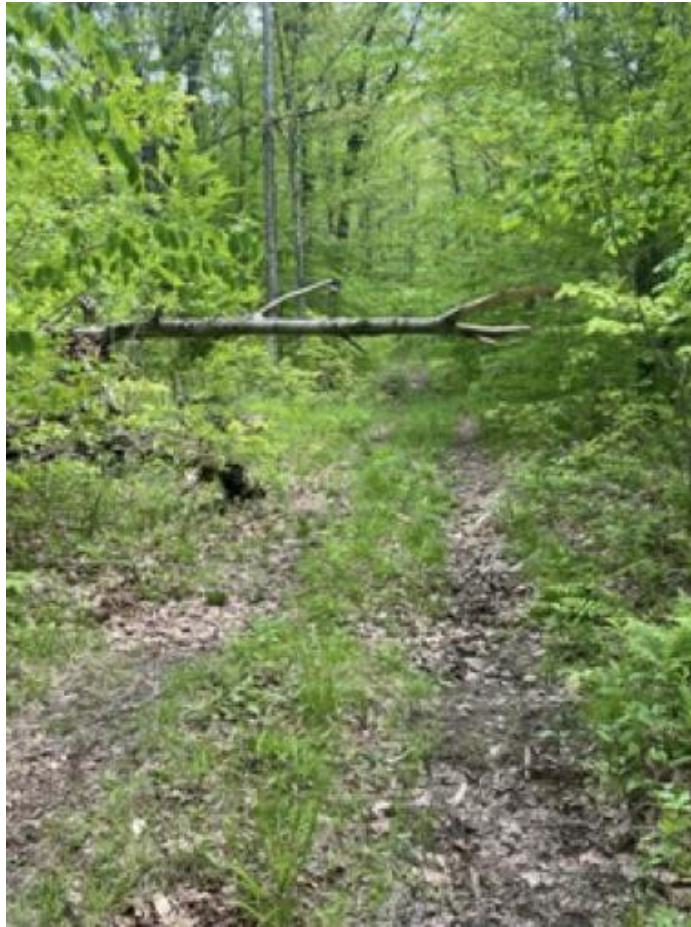
0.53 Road condition moves from FAIR to GOOD. A bit more wash out from the heavy rains. Just above the 1<sup>st</sup> cellar hole there is a tree across the road. Able to walk under it.

Obstructions: Extensive and significant erosion on the Eastern section makes road essentially unpassable. Two trees down on the Western section.

*Tree Across Road 2025*

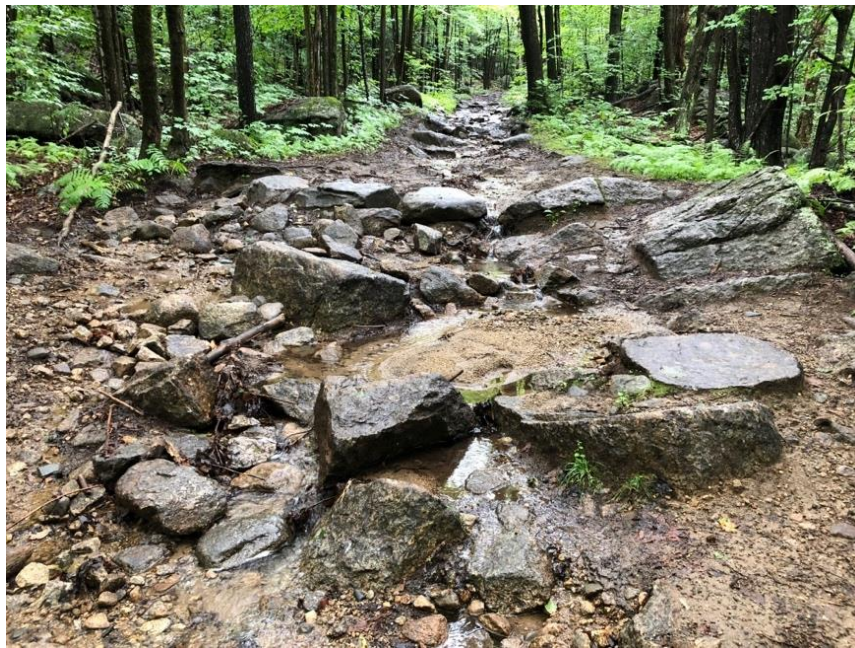
0.93 Road condition deteriorates to POOR with extensive washouts and large rocks. Observations in 2025 finds that this section continues to deteriorate.

*Washed Out Section 2018*

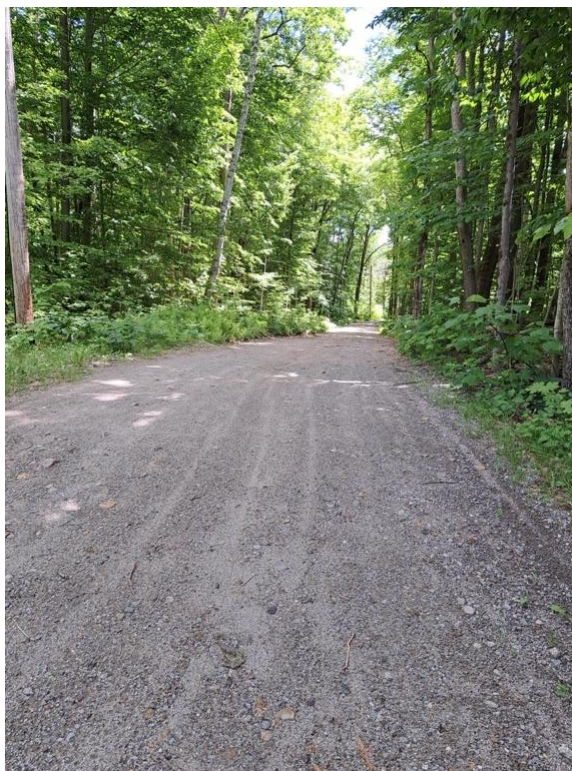
*Fortunes Road 2025*

Narrative: The Class VI portion of Fortune Road (past the McDonald residence) is maintained in EXCELLENT condition by routine grading and addition of hard pack as needed by McDonald. It is used year-round by Joy Nowell to reach her home in Newbury, located just over the Bradford town line. The length of this section is approximately 0.5 miles

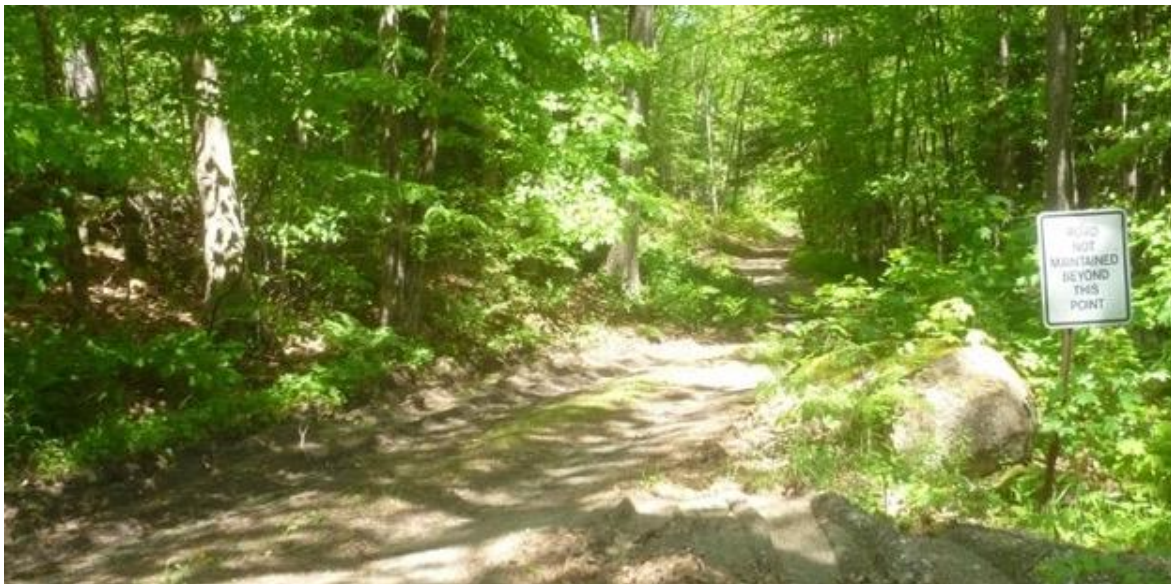
*Jackson Road 2022*

Erosion: Yes, in multiple places, notably around the driveway to 243. Overall, the road is generally in GOOD condition with the exception of several mud holes. 2025 update finds that Jackson Rd is still in good shape and easily passable with any vehicle.

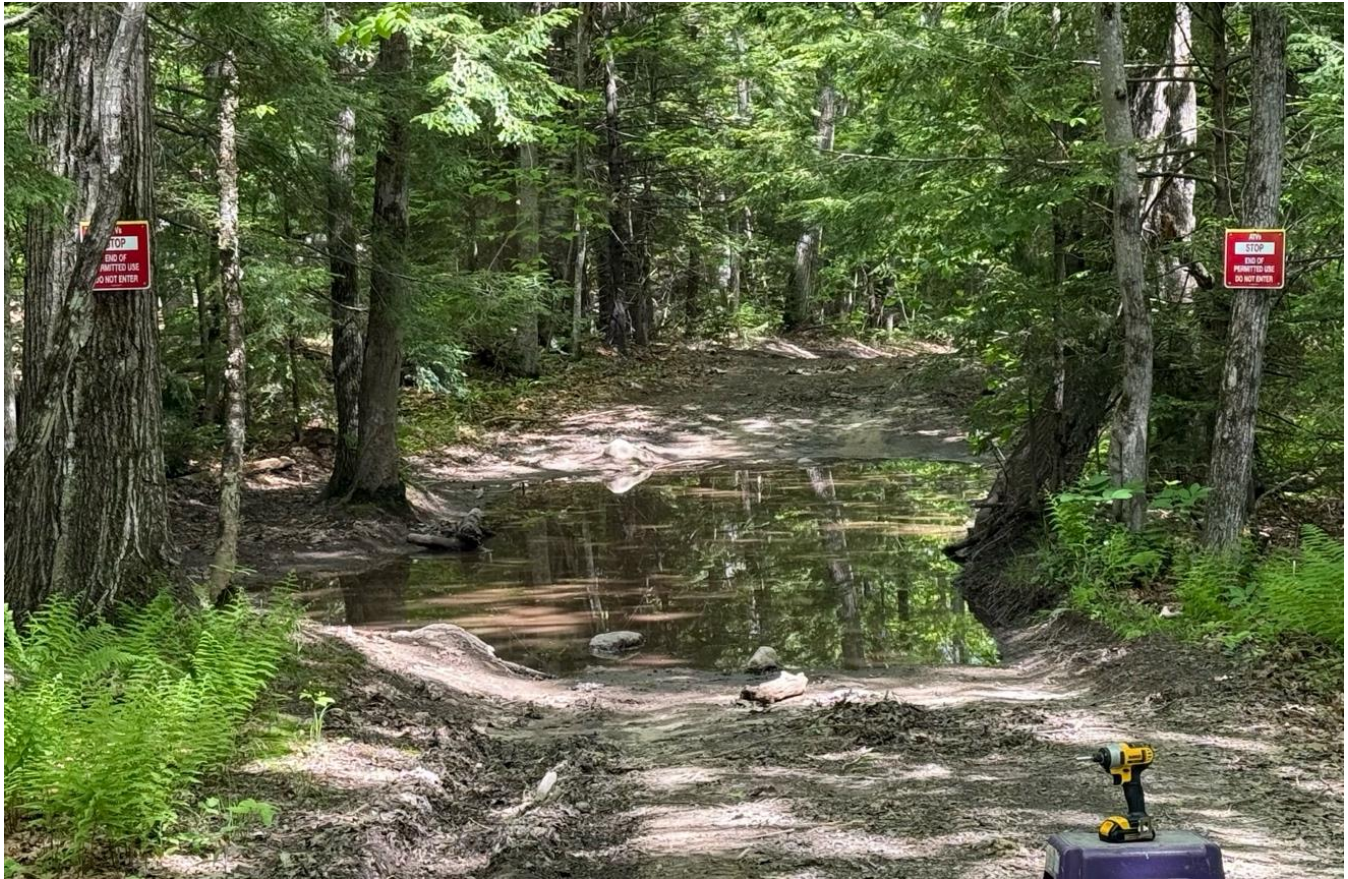
*New "End of Permitted Use" Signs 2025*

Monitor Actions: New "End of Permitted Use" signs installed in June 2025 on both sides of road at Bradford/Henniker town line. Signs obtained from NH Bureau of Trails after consultation with Craig Rennie, Chief Supervisor and notification to Contoocook Valley ATV Club via Nancy DeMoura, Secretary of Contoocook Valley ATV Riders, who was supportive. Verification that signs are currently in place was conducted on July 29, 2025. Significant reduction in OHRV traffic noted on Rowe Mountain Road in summer 2025.

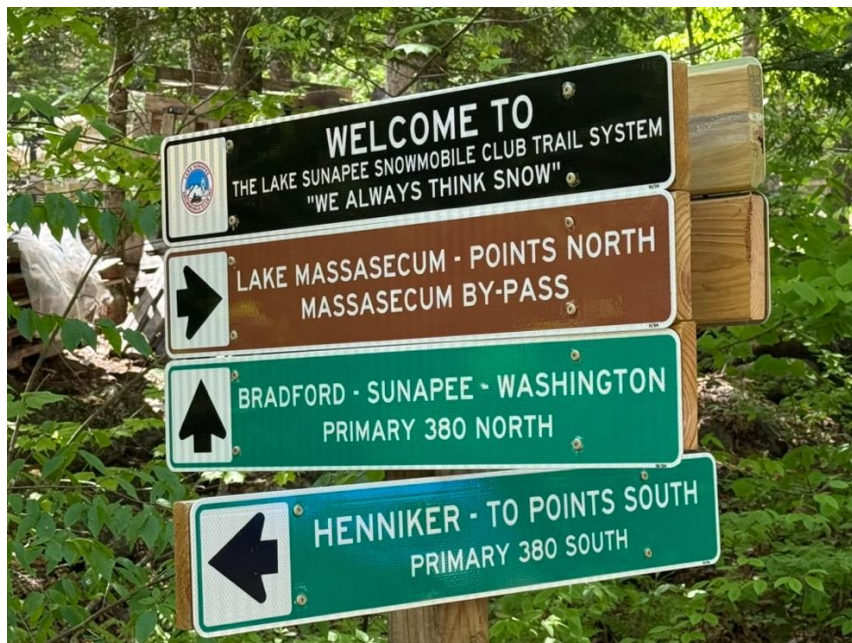
Recreational Vehicle Trail Signage: New snowmobile trail signs noted at junction with Rowe Mtn, Day Pond and Carter Hill Roads. Regular transit of Jeep/truck caravans reported.

*New Snowmobile Club Signs 2025*

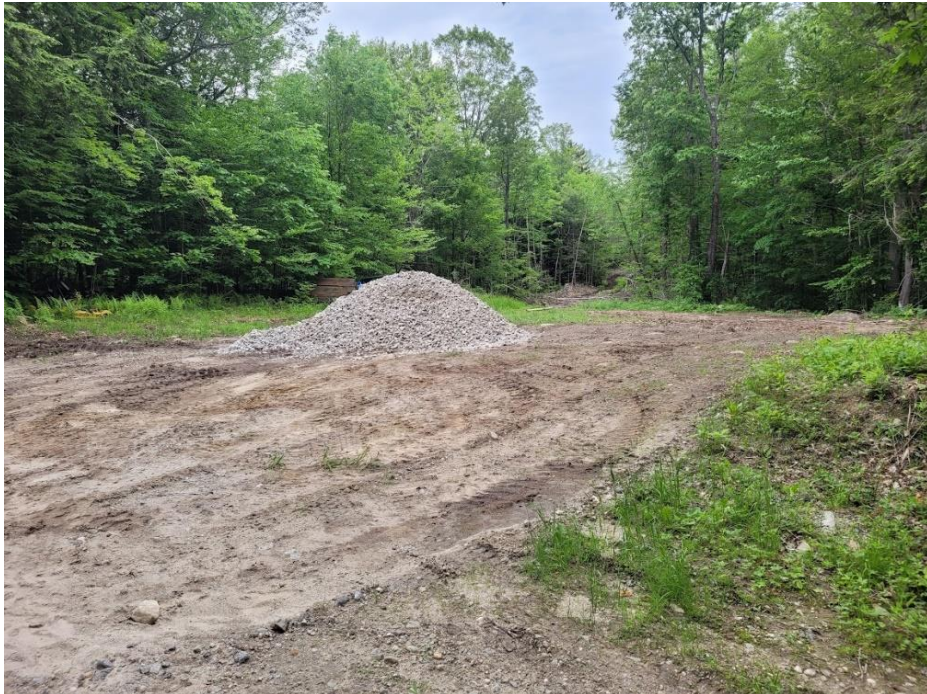
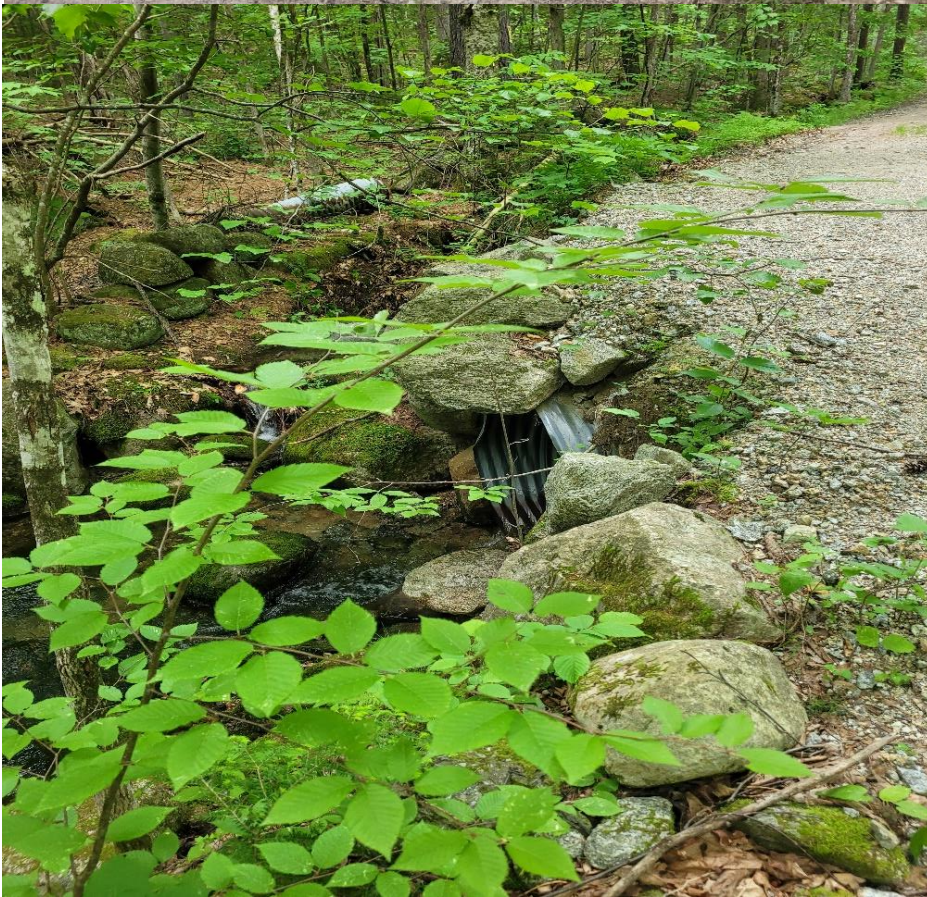
2025

Mile 0.9 to 1.2 - From the Butler driveway to the Washington town line, the road is in POOR condition. The roadway has become a stream bed flowing for much of the year, and it has eroded to boulders, rocks and cobbles. The road is not posted at the Town Line.

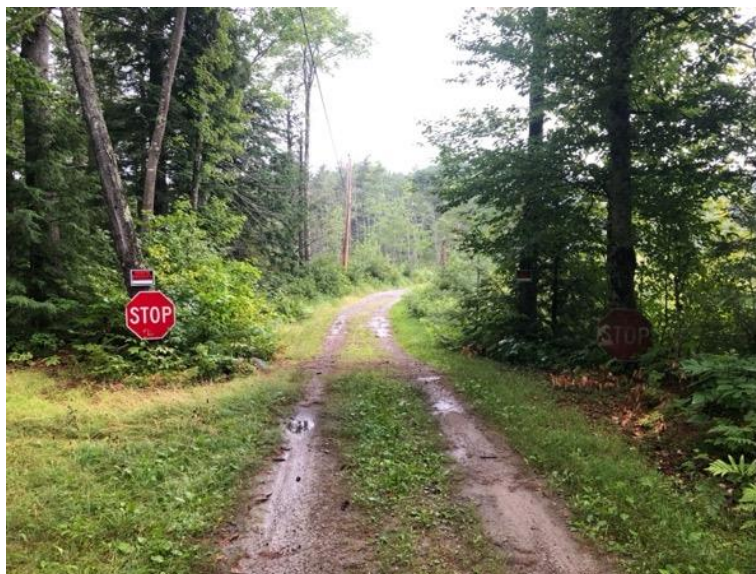
0.16 Road primarily level and in GOOD to EXCELLENT condition. Appears to be privately maintained. At 0.16 miles there is signage indicating transition to private property. A new STOP sign appears to be recent as of 2024.

*Signage at end of Purrington Road*

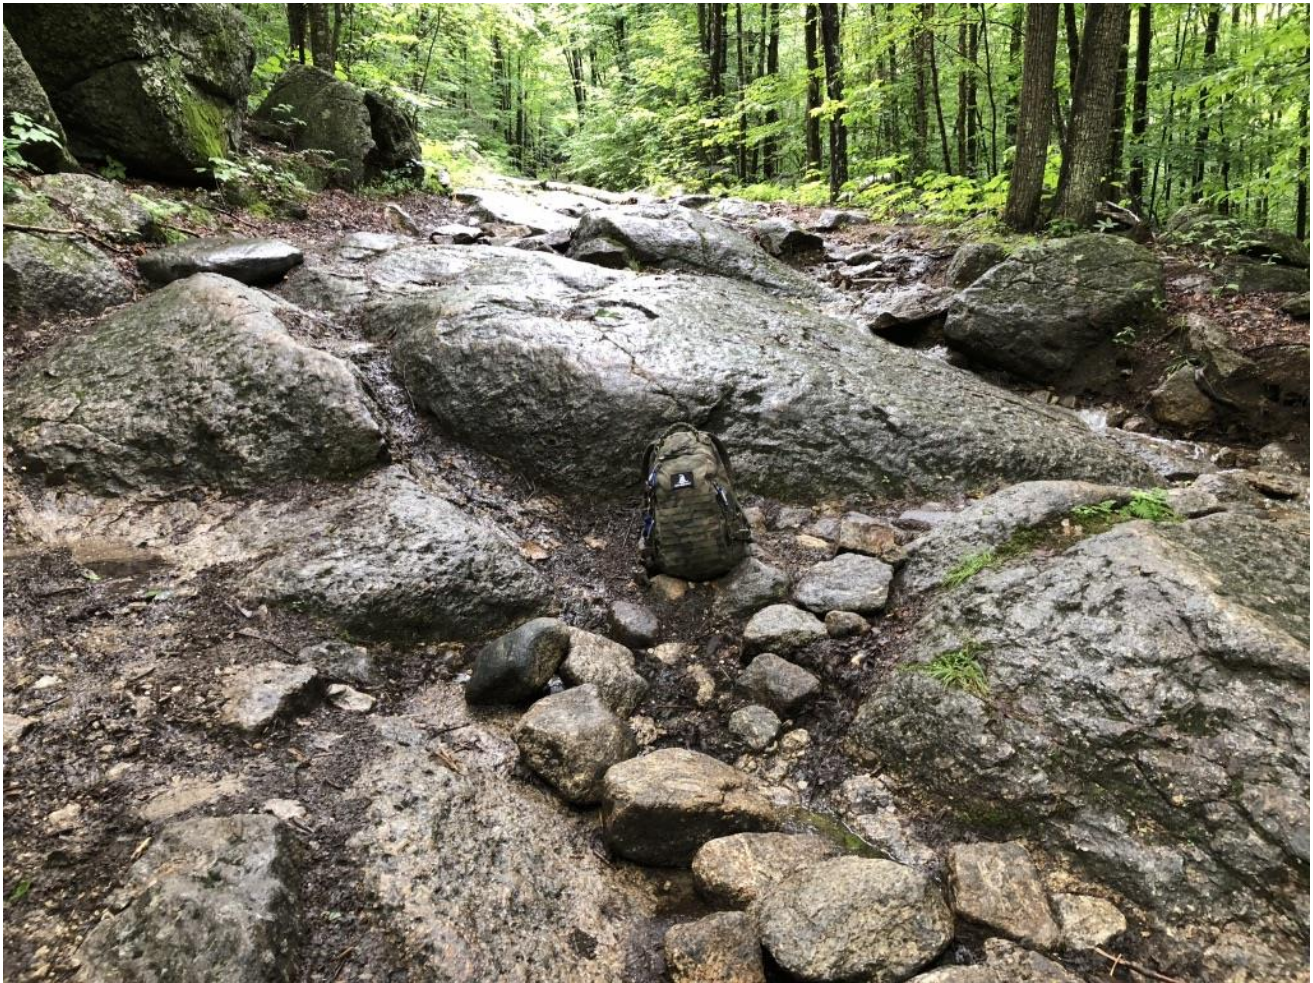
- 0.65 Snowmobile trail detour to the left (Northside).
- 0.75 Road conditions deteriorate substantially. Gentle downslope with significant rock outcropping, ledge and general erosion. Road condition is POOR.

*Erosion on Rowe Mtn Road 2018-25*
