# *Adopt a Road*

## Bradford Conservation Commission Summer 2025 Report

## Summer 2025 Update

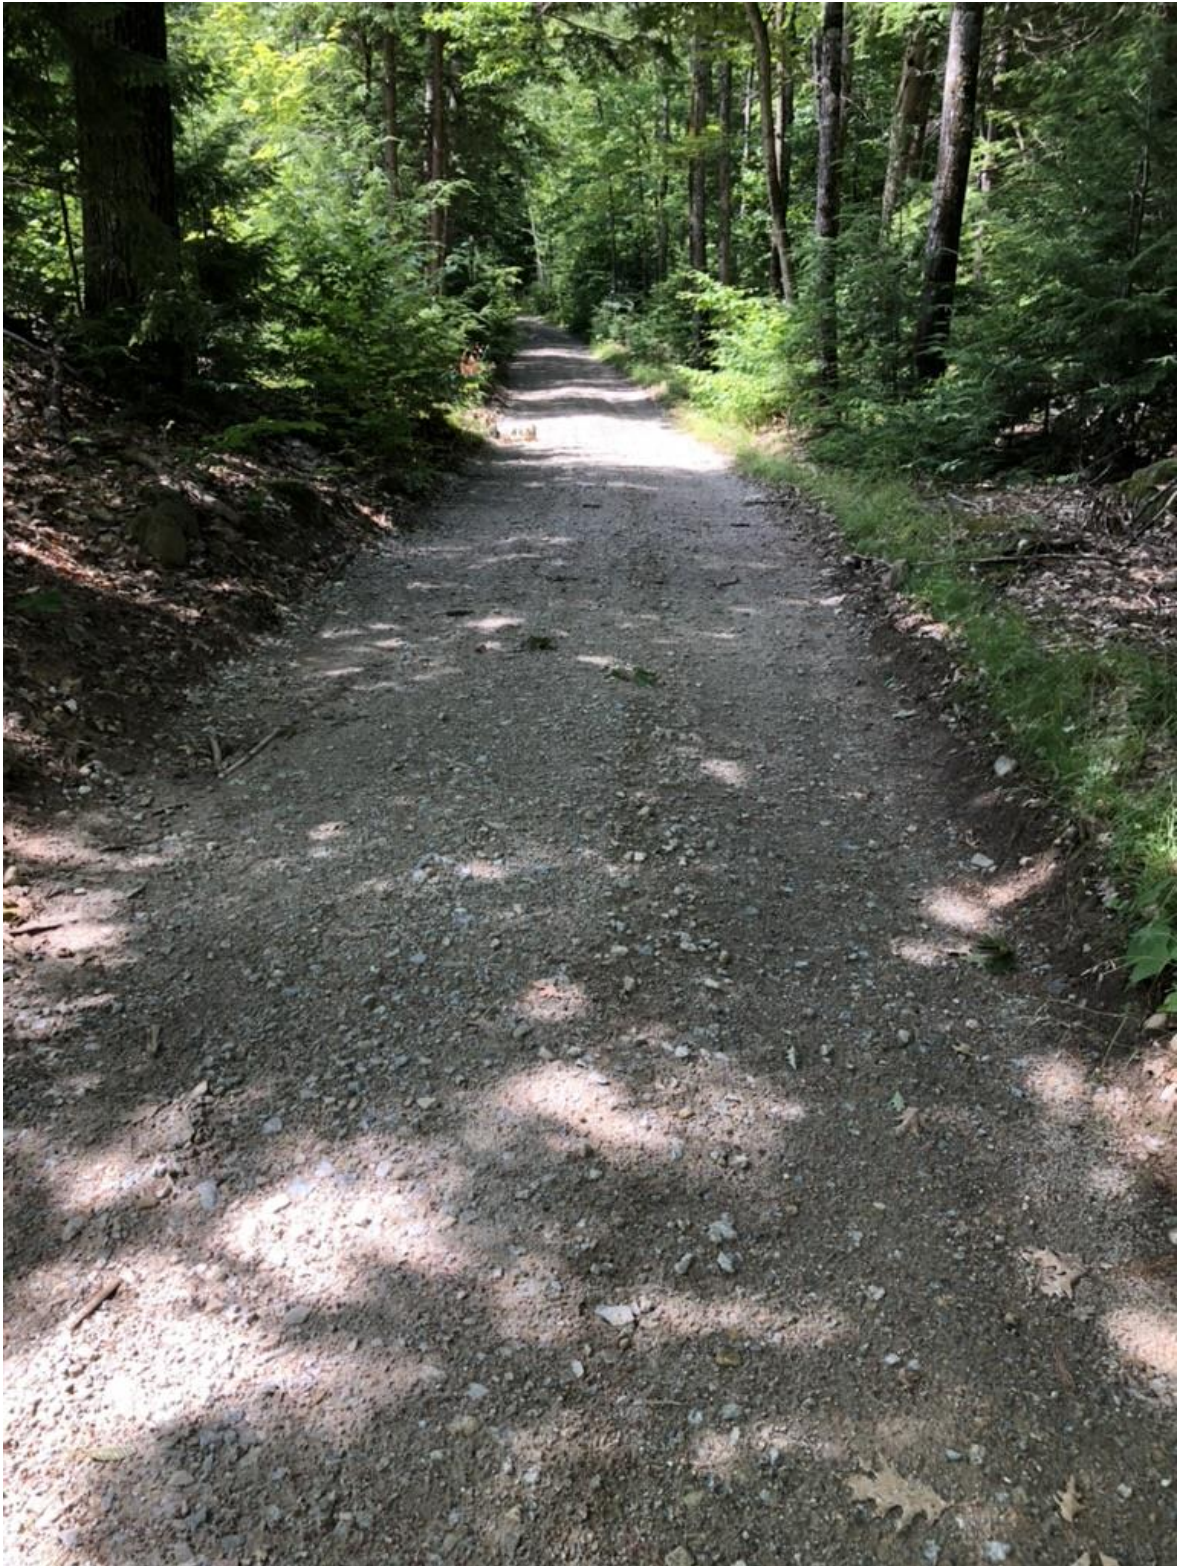
Erosion: Conditions from Forest St to Tuttle Rd are EXCELLENT. The improvements made last year by the landowner on Tuttle Rd have held up quite well. From Tuttle Rd to Rowe Mt Rd some sections have been filled with crushed rock and are in good shape.

*Privately Upgraded Road Surface July 2024*
