Adopt a Road

Bradford Conservation Commission

Summer 2022 Report

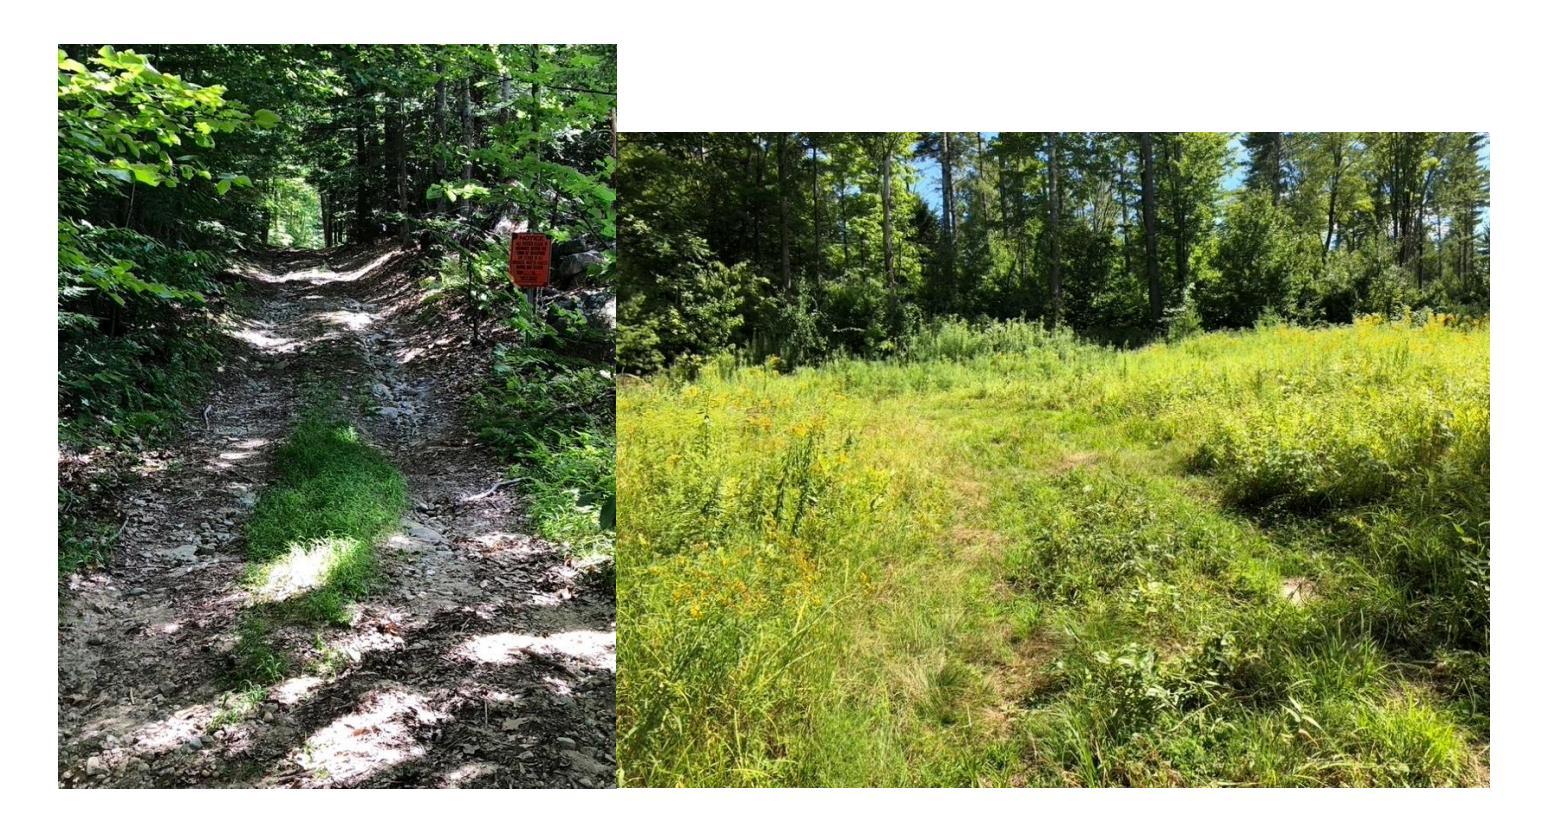
Carter Hill Road

0.0 - 0.17 miles: Road climbs steeply uphill immediately from Day Pond/Massasecum Ave./Rowe Mt. Rd. junction. Road condition is Poor, mostly exposed rock with some sandy areas. Large fallen hardwood tree partly obstructs the road about 50 yards in.

0.17 - 0.25 miles: Road condition very Poor, washout heavier, steep grade continues.

0.6 - 0.75 miles: Road climbs steeply, extremely eroded, no soil present, small stream running down. Road condition extremely Poor.

0.85 - 1.0 mile: Road climbs steeper again, condition very Poor to top of hill and town line.
